Current-Induced Fatigue in Chip Level Interconnects

R. R. Keller and R. H. Geiss,
N.I.S.T. Materials Reliability Division
Boulder, CO

C. A. Volkert, R. Mönig, O. Kraft, and E. Arzt
Max-Planck-Institut für Metallforschung
Stuttgart, Germany

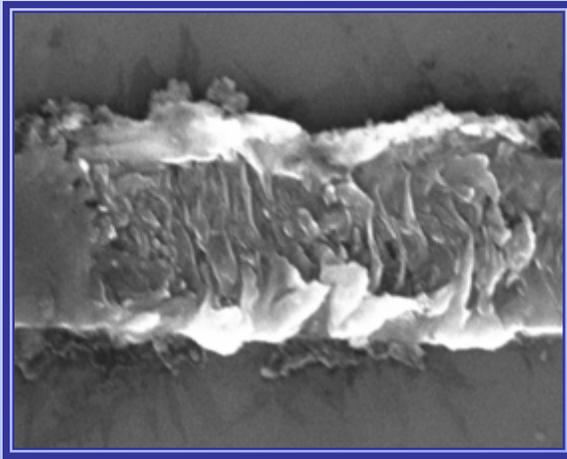
A.C.

Severe topographic changes
Damage distributed over entire line length
Periodic surface “wrinkling”

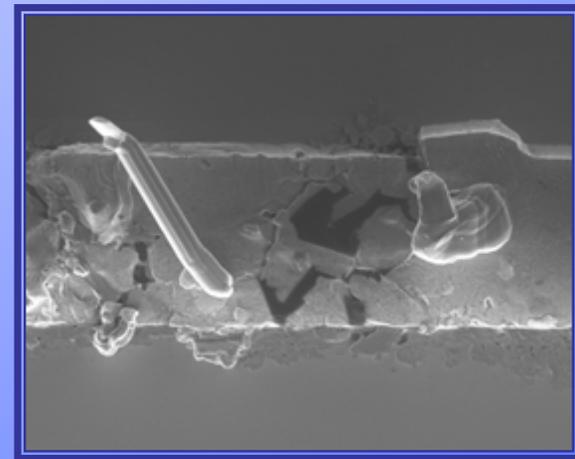
D.C.

More modest topographic changes
Damage confined to fewer sites
Void and hillock formation

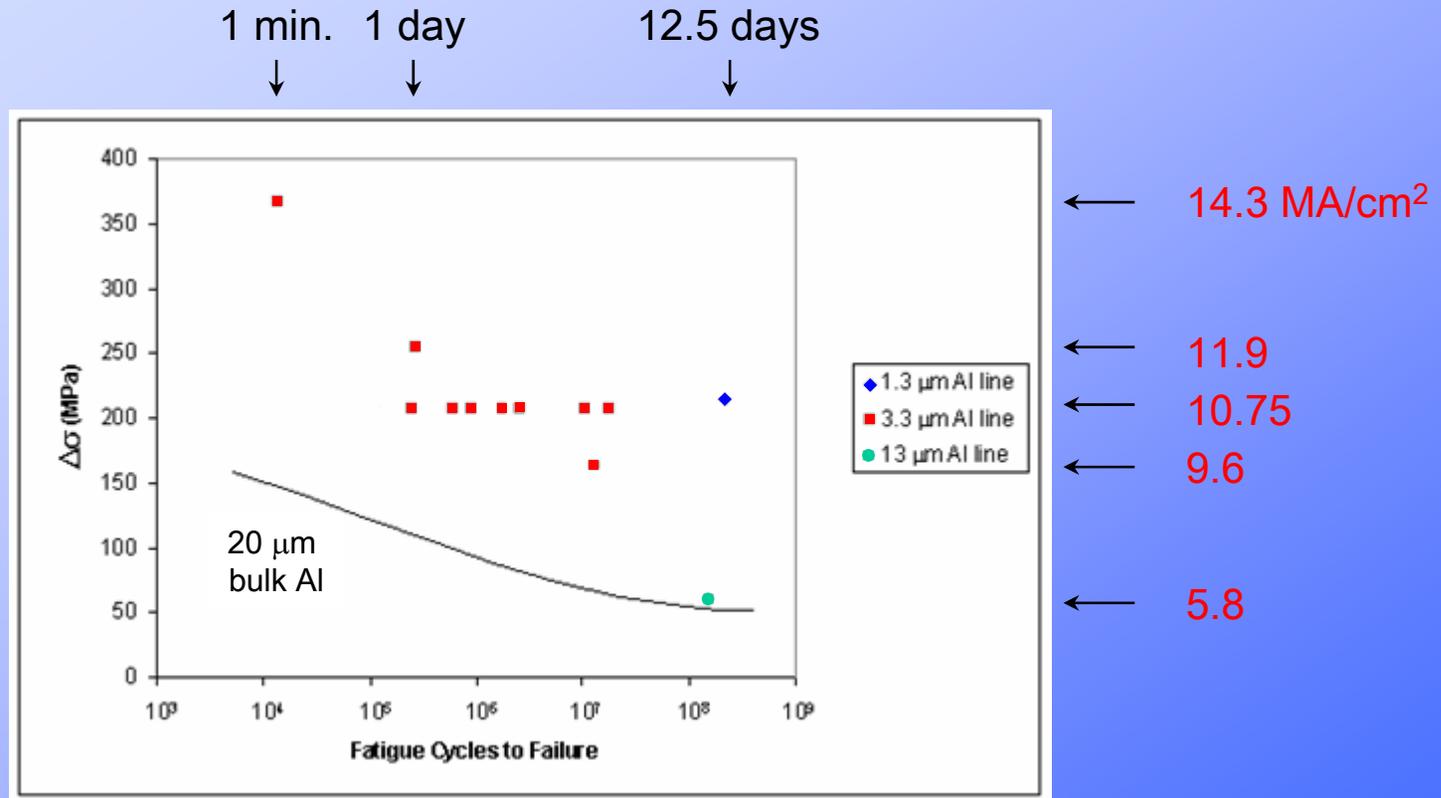
Lifetime Plot for A.C.-tested Al-1Si

- Lifetimes to open circuit show fatigue-like behavior
- Stresses are higher, presumably due to film thickness and fine grain size effects
- Linewidth effect on lifetime, if any, still unclear

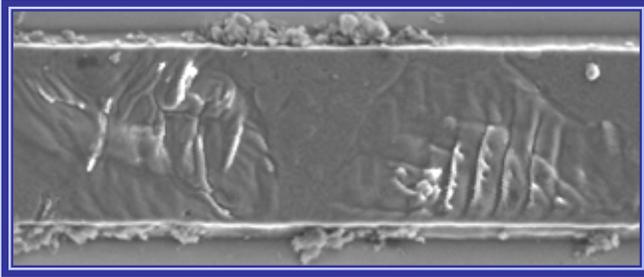
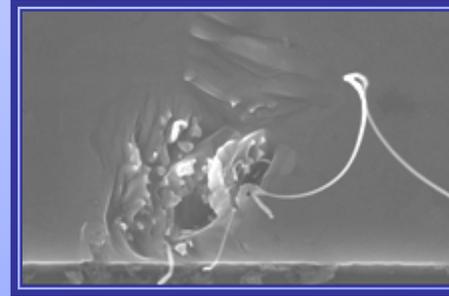
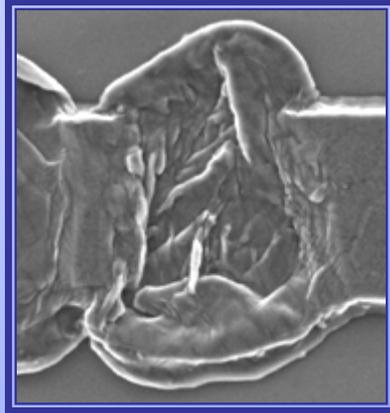
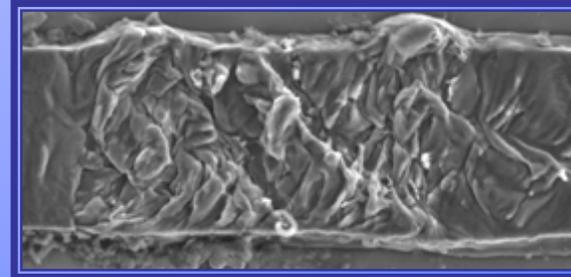
Examples of Damage

Damage is very site-selective, suggesting microstructural influence.
Small damaged regions become larger damaged regions.
Severe effects such as extrusion, whisker formation, and cracking observed.
Open circuit occurs only in more severely damaged regions.

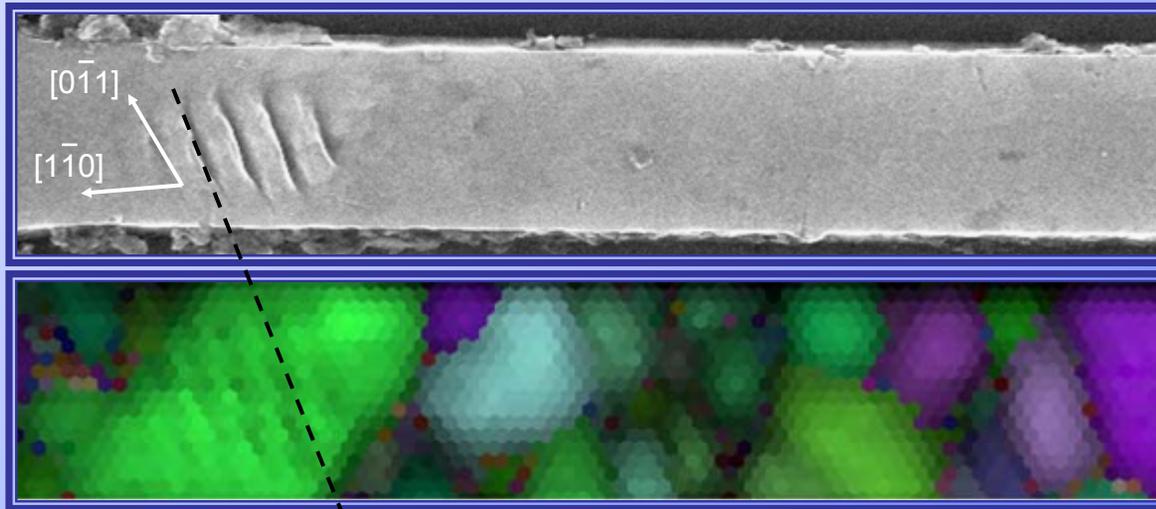
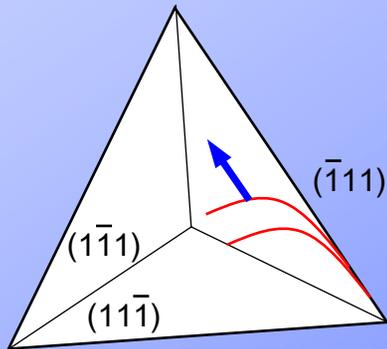
45 s at 12 MA/cm²

Conventional glide can explain topography during early stages of testing.

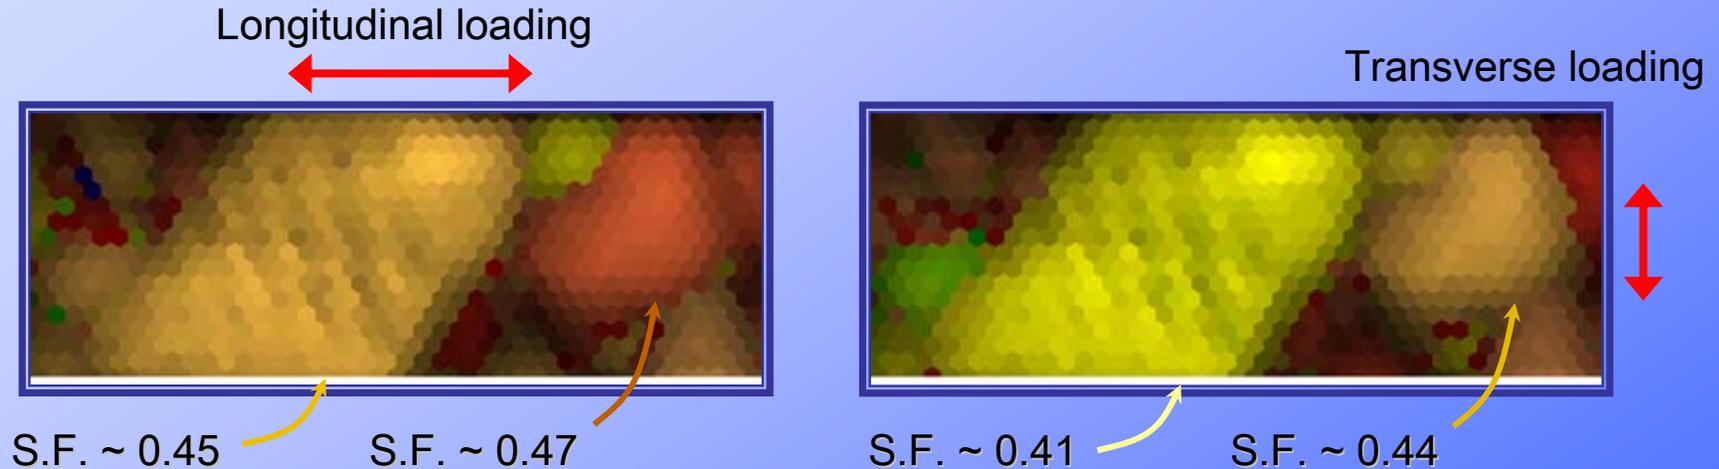
Topography 2 – Site Specificity

- Grain that yielded did not have the largest resolved shear stress for either longitudinal or transverse loading.

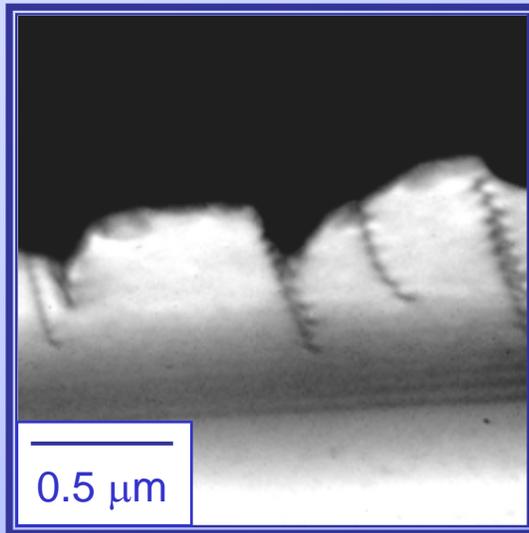
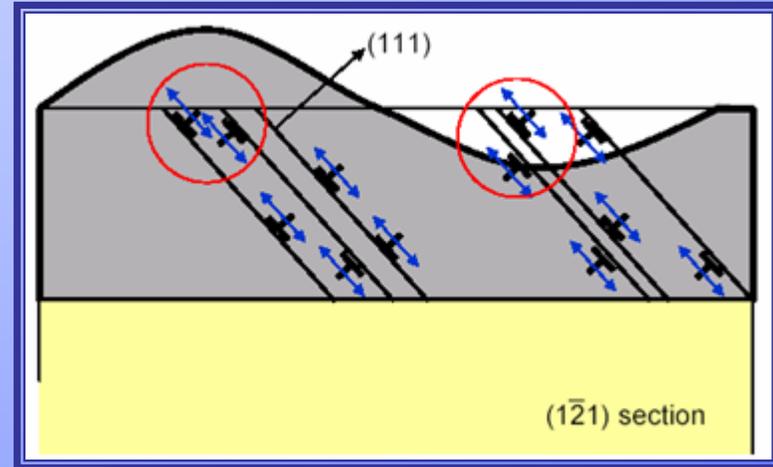
Topography Summary

- Wrinkling is consistent with slip line traces associated with usual fcc slip systems of $\{111\}\langle 110\rangle$. These can form in under 60 s.
- Even after millions of cycles, no lower-energy dislocation structures were observed. Related to constrained volume available for deformation?
- Largest Schmid factor (assuming uniaxial loading) does not necessarily determine slip order.
- Must consider also effects of grain size and multiaxial stresses for predicting slip order.

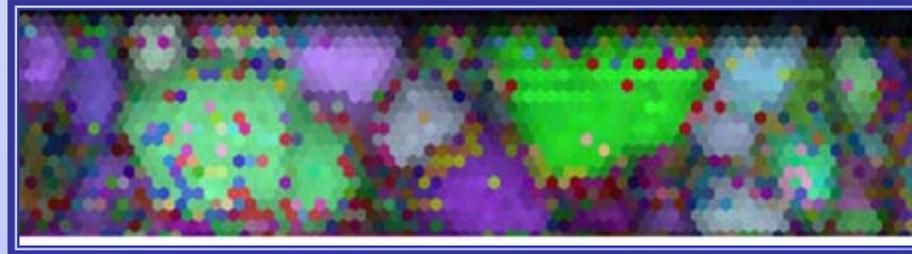
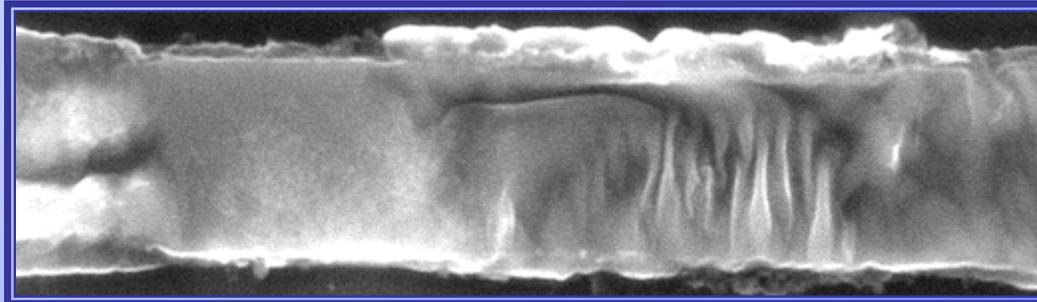
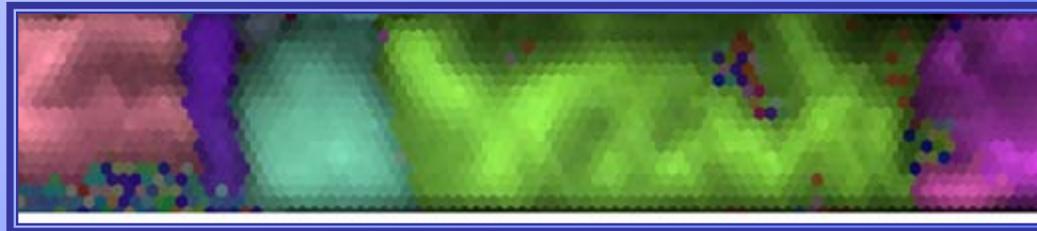
60 s at
12 MA/cm²

Deformation accompanied by grain growth!

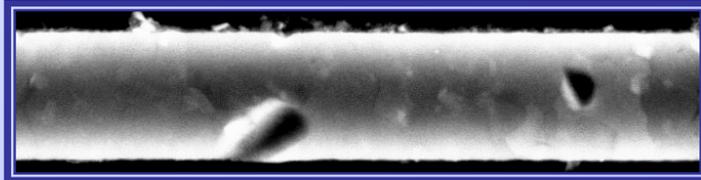
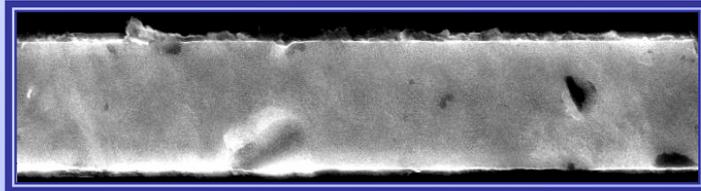
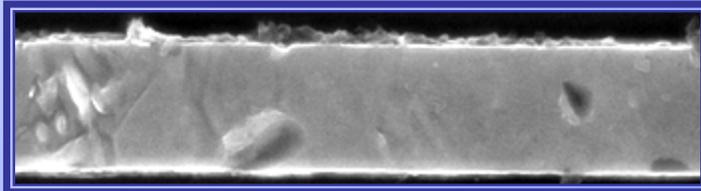
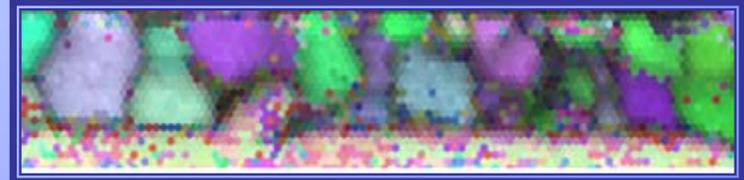
Grain Growth

Observed growth in grains showing no slip lines.

Light blue grain shows onset of slip at 60 s, *after* significant growth.

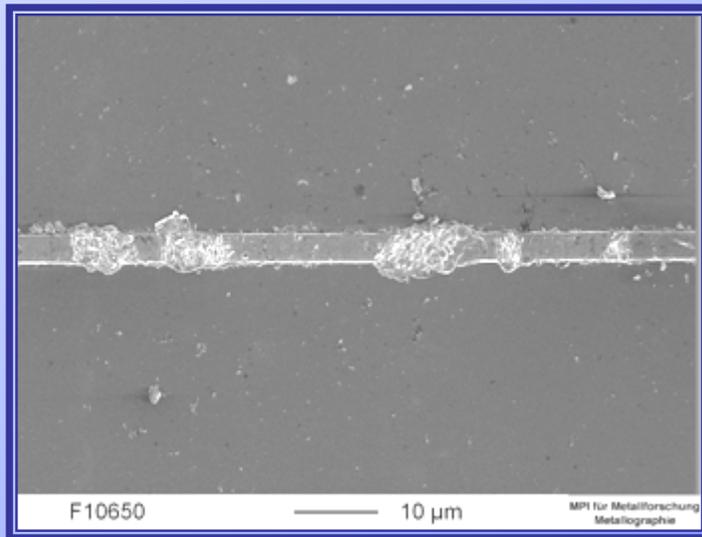
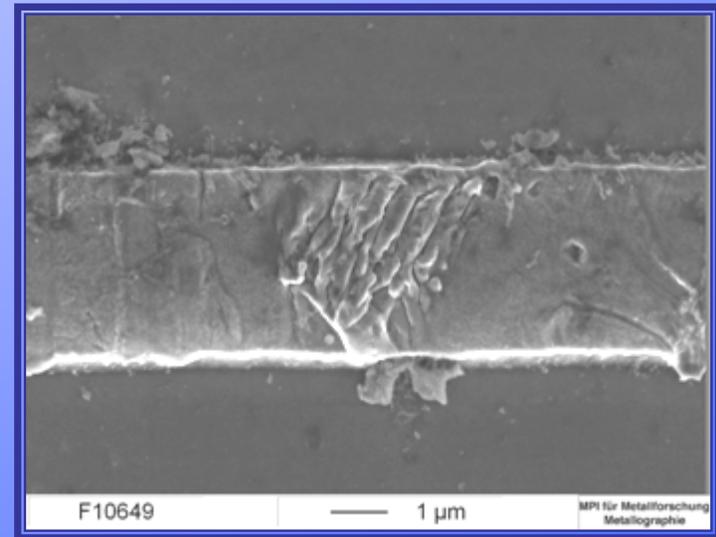
Coated with 2 μm photoresist (cured)
Tested in A.C. at 11 MA/cm^2
Photoresist stripped in acetone

Relatively soft encapsulant does not change damage morphology in Al.
Tests yet to be performed, but damage in unpassivated Cu is in many respects
similar to that in Al...
