Preprint: NIST Technical Note 1545

Attenuation of Radio Wave Signals Coupled Into Twelve Large Building Structures

NIST Technical Note 1545

May 2008

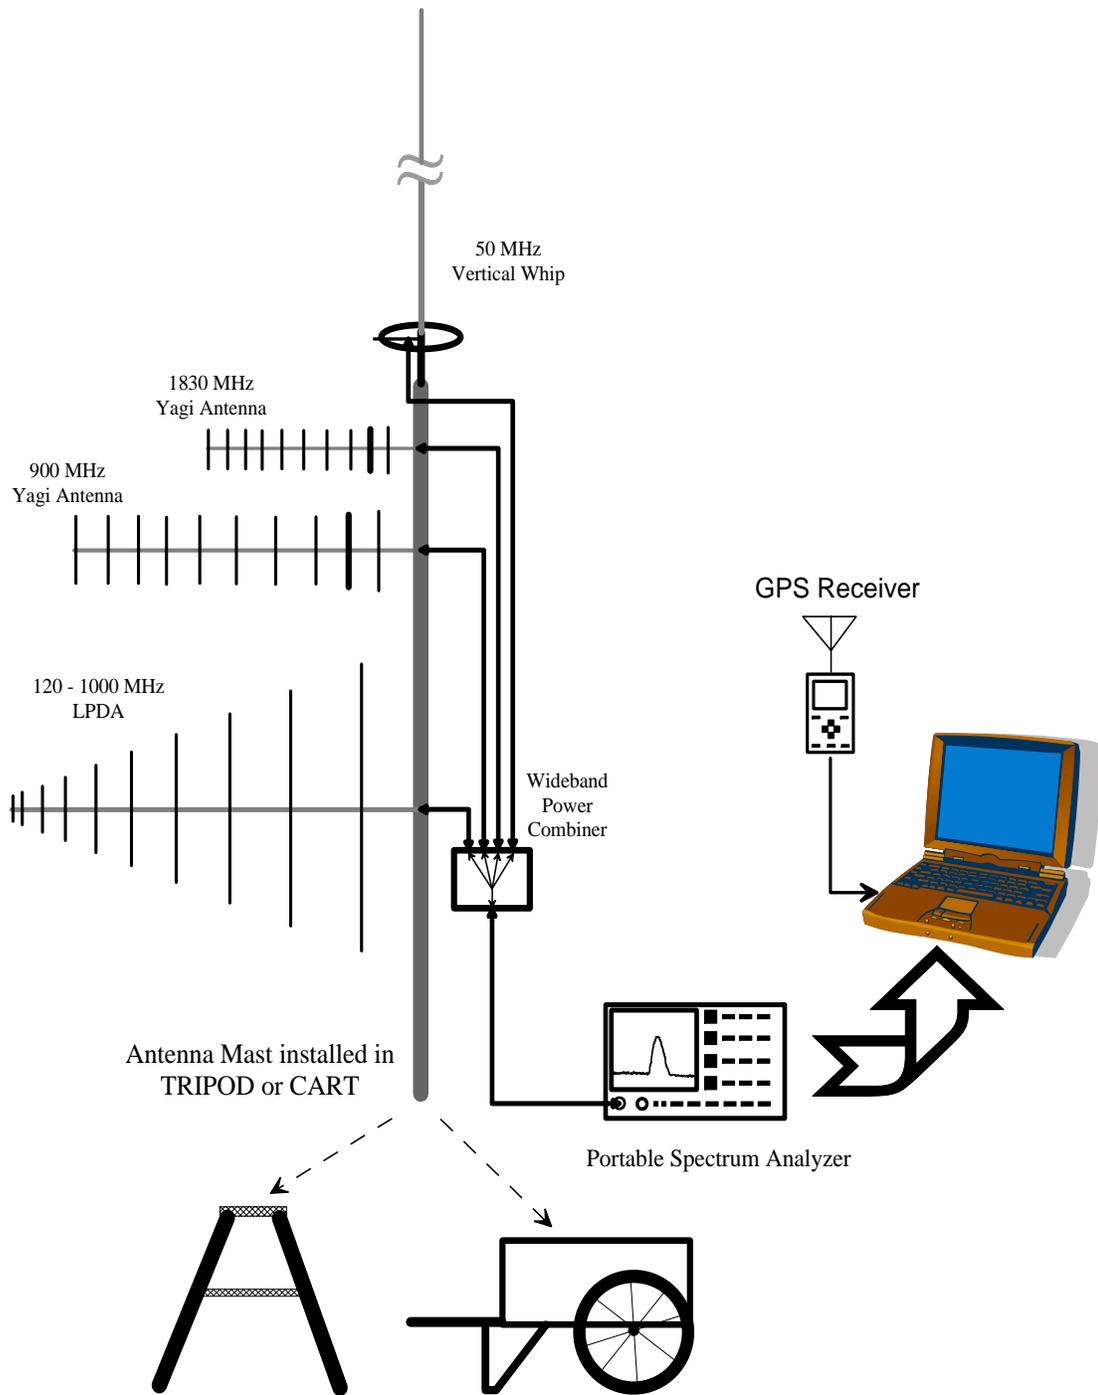
Figure 3. Schematic of the receiving system for the building penetration and field-mapping experiments.

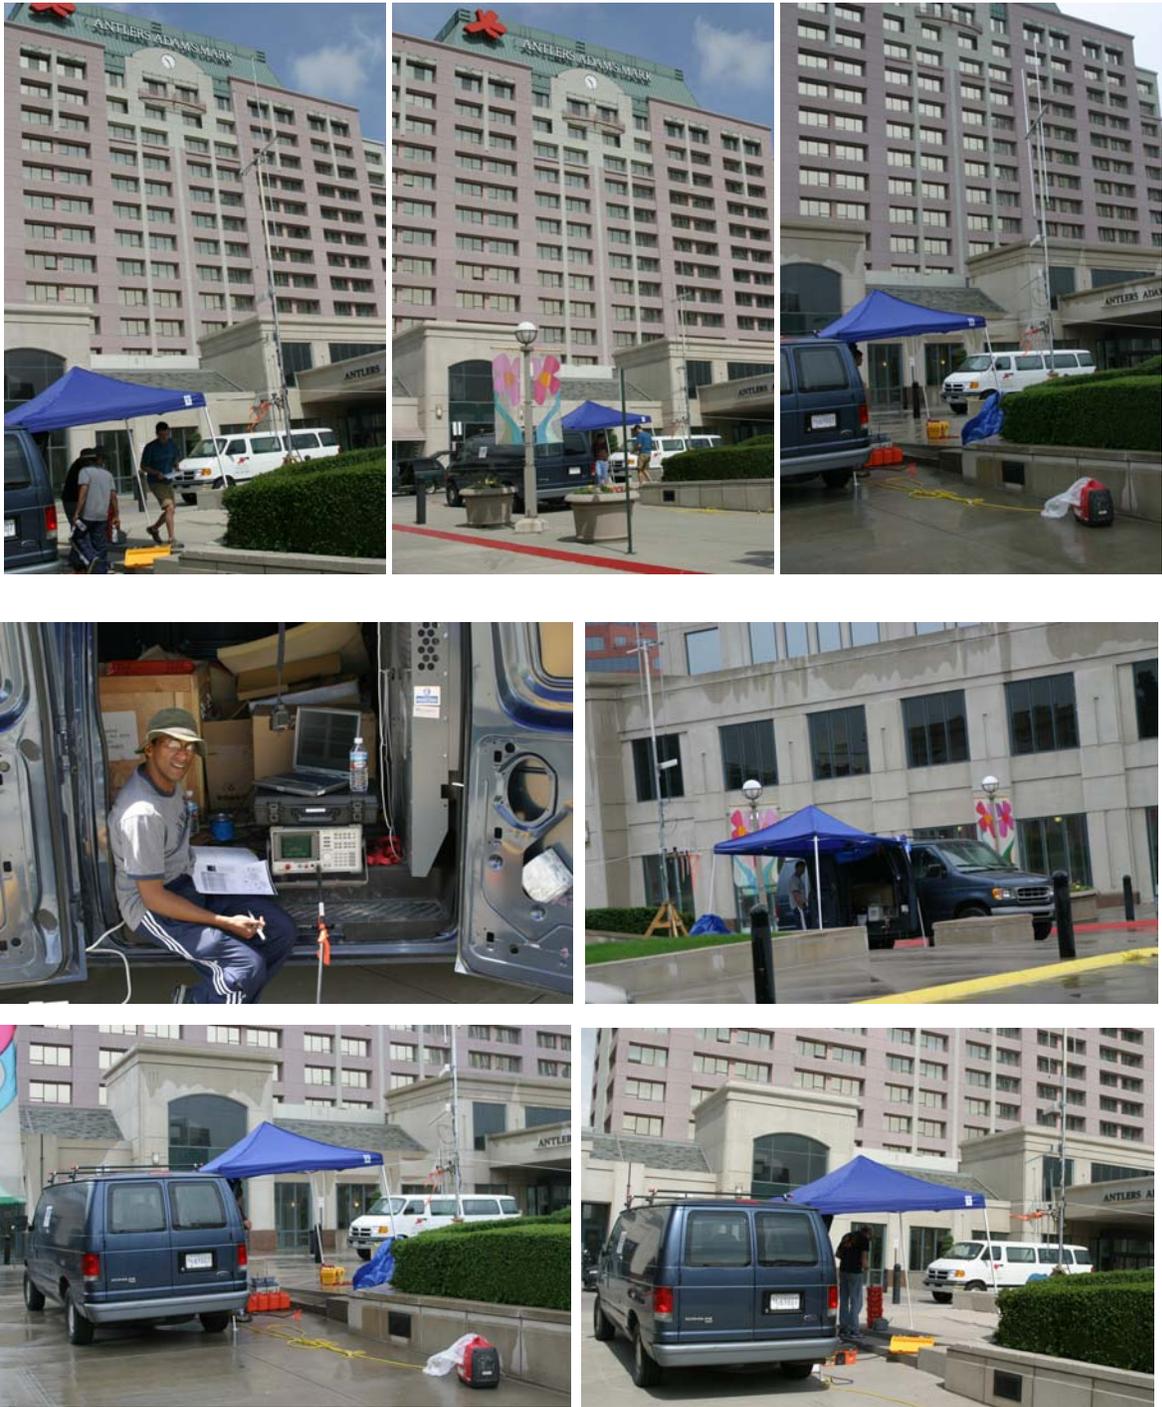
Figure 17. Receiver location and layout for the Colorado Springs hotel complex.

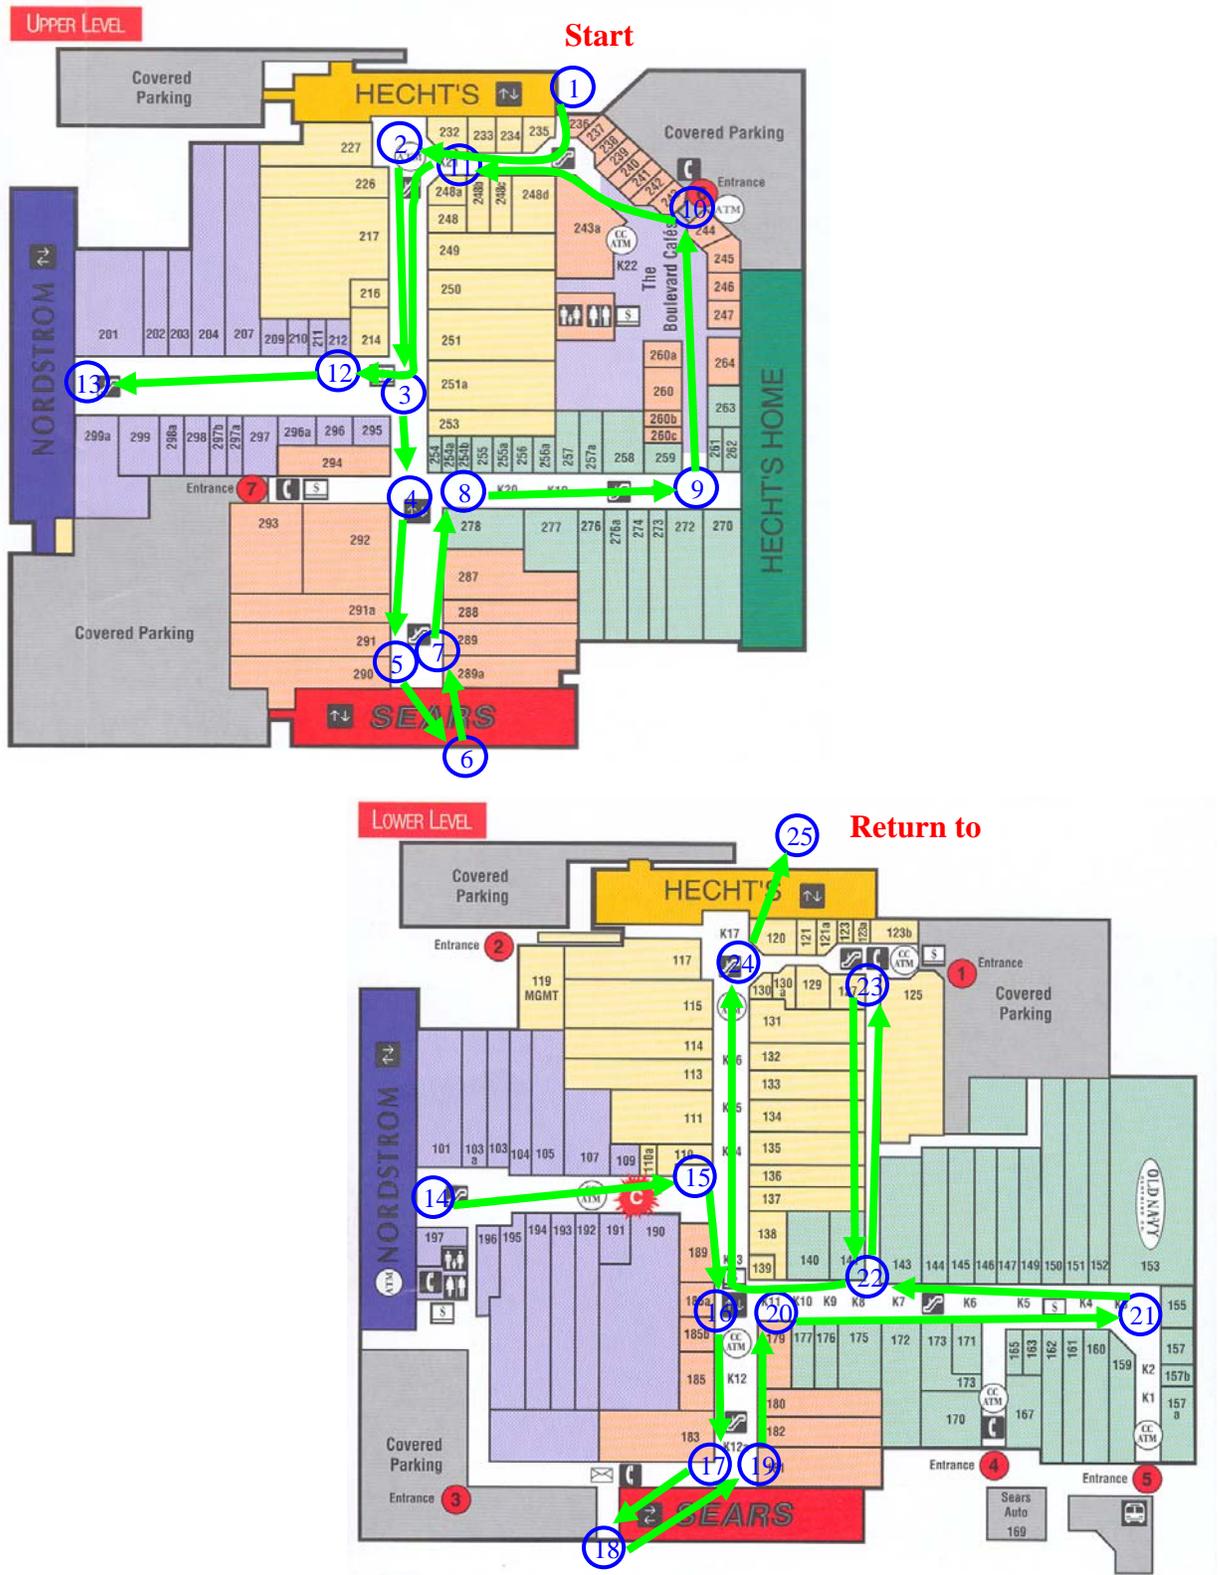
Figure 26. Upper and lower level floor plan with the predetermined locations on both levels of the shopping mall. The green arrows in the figure represent the actual paths that were walked.

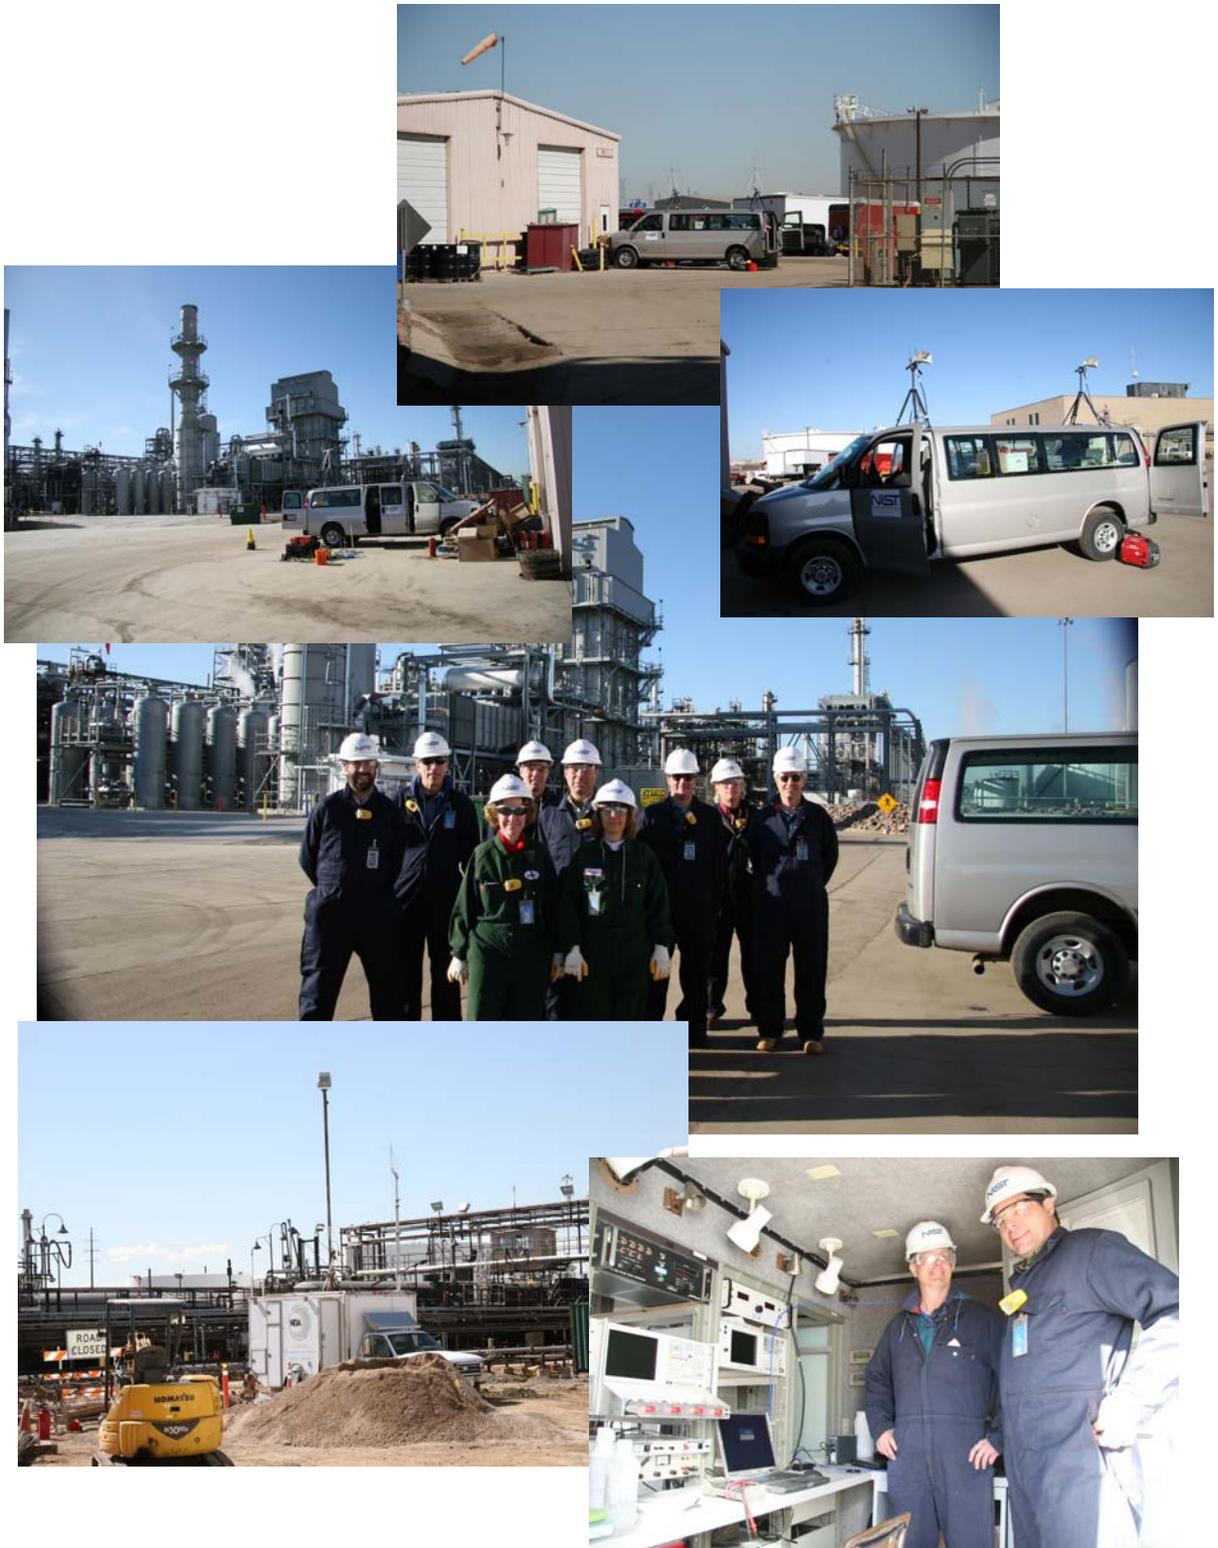
Figure 39. The receiver locations at the SUNCOR oil refinery in Commerce City, CO.

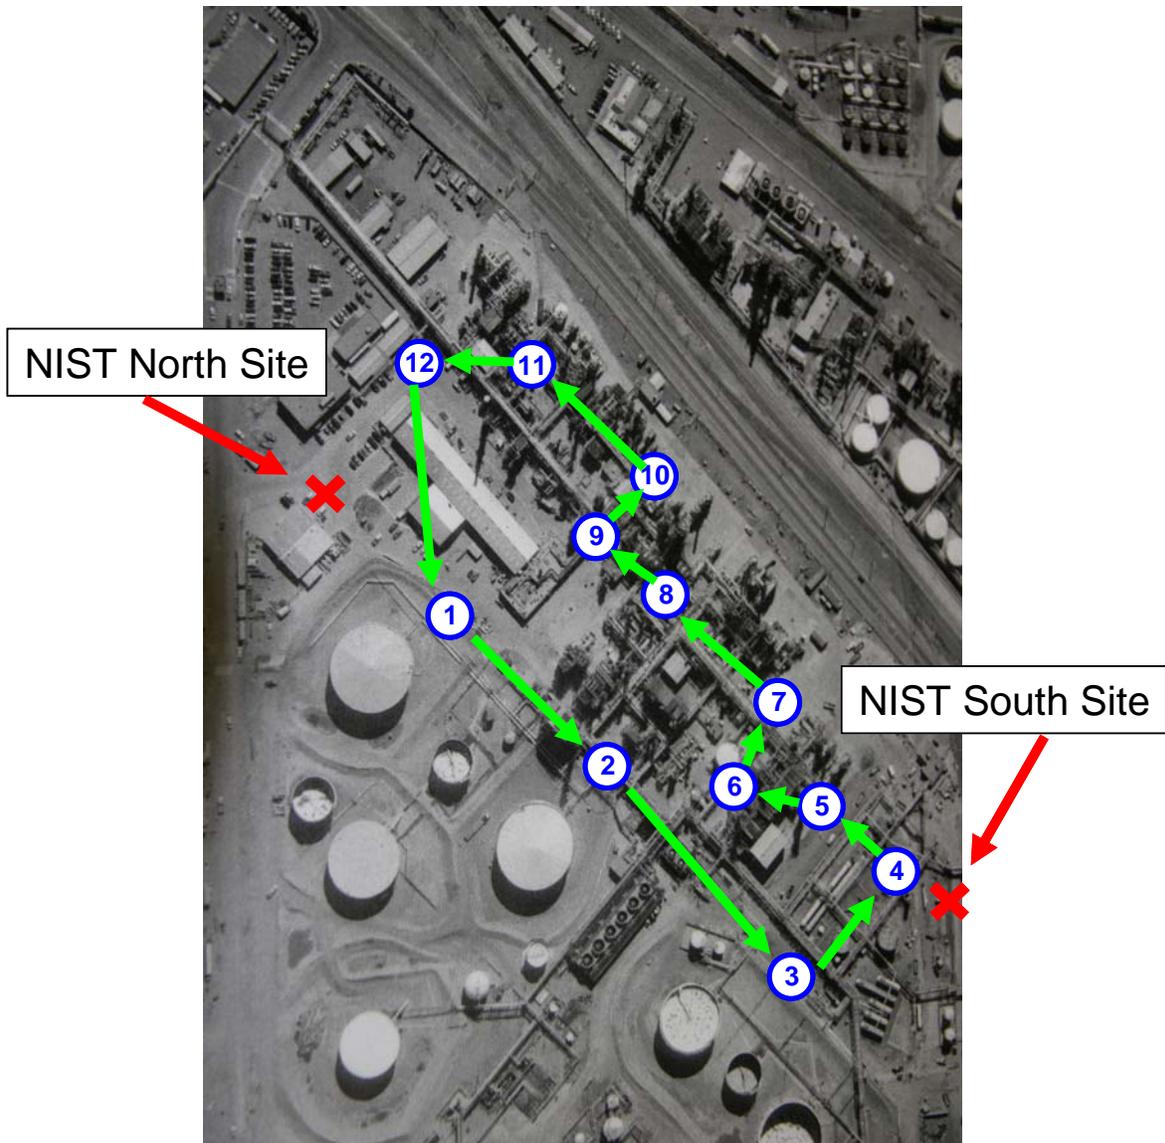
Figure 42. Receiver location and layout for the Commerce City, CO oil refinery.

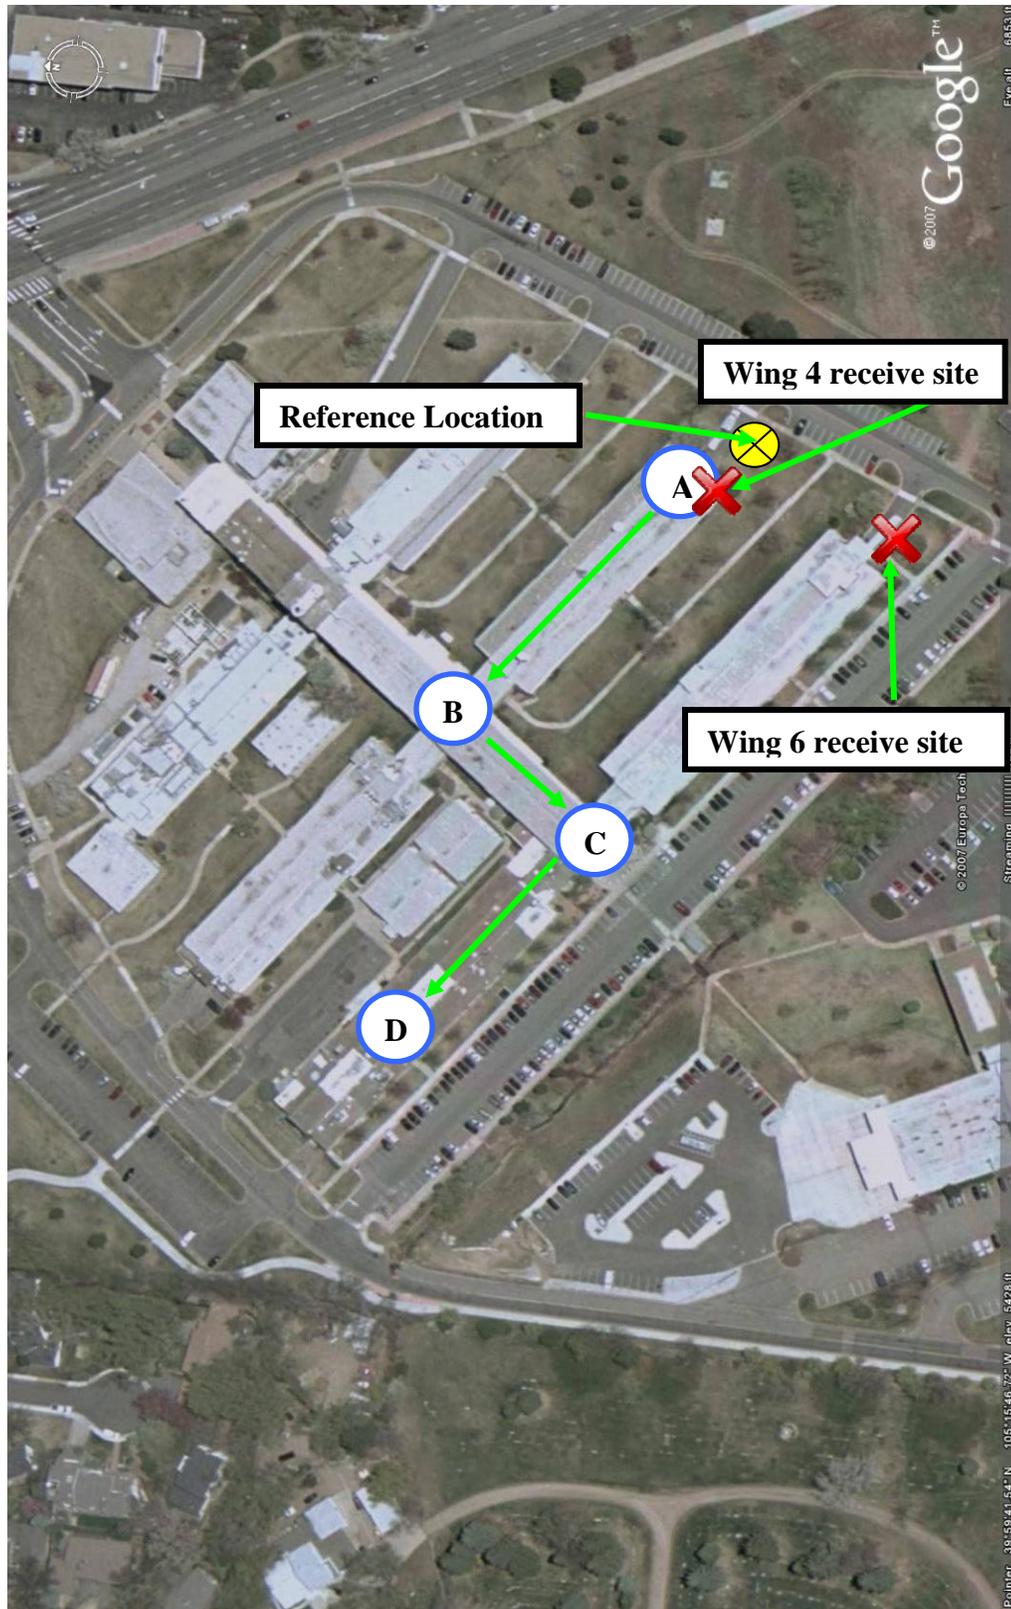
Figure 45. Receiver location and layout for the Boulder, CO laboratories.

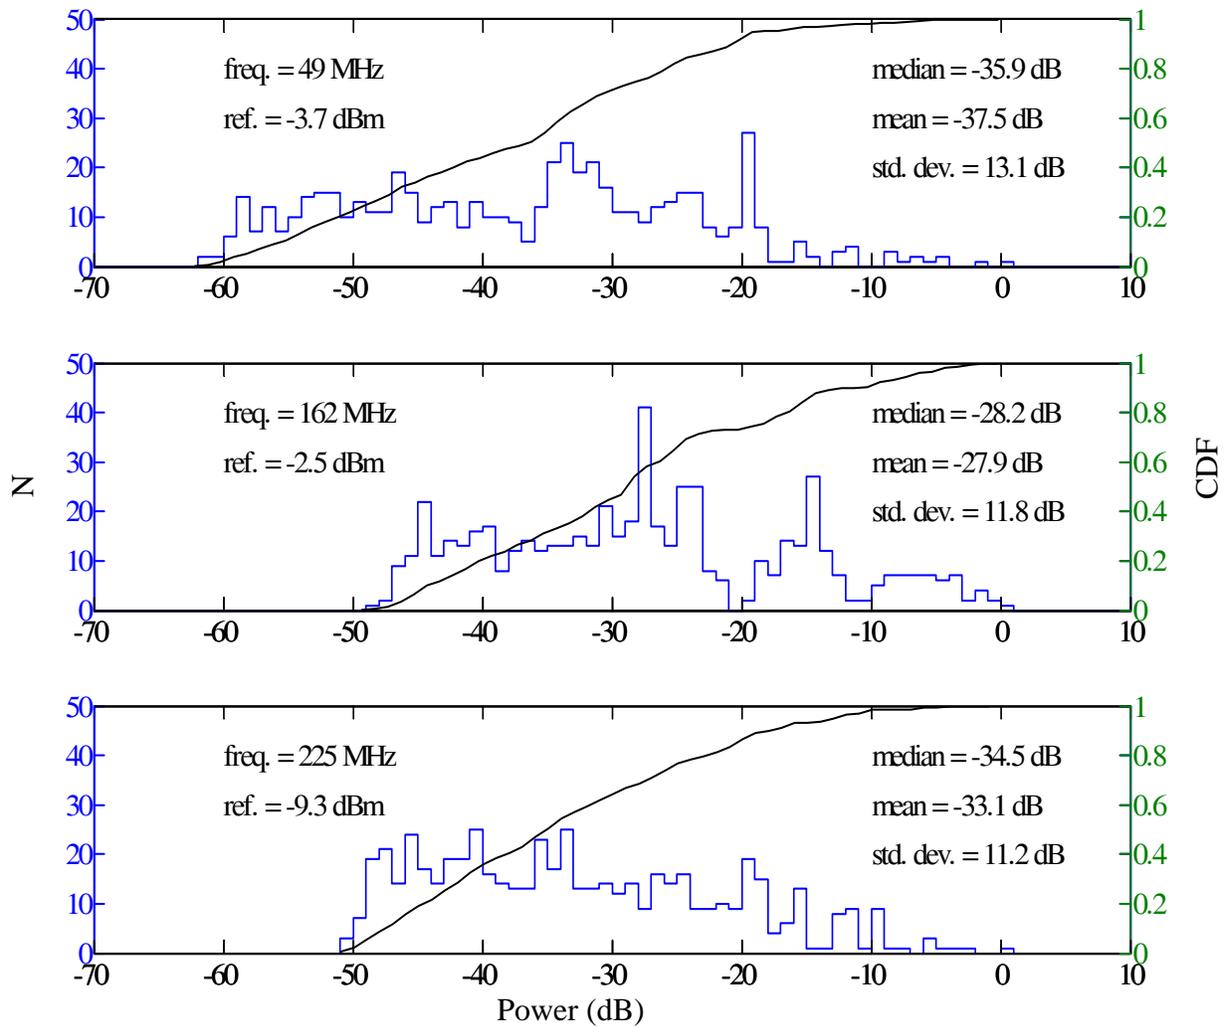
Figure 52. New Orleans apartment building statistics, histograms, and empirical CDF for walk-through data at 49.60, 162.00, and 225.375 MHz.

The apartment building in New Orleans provided the first set of data collected (in chronological order). Plots of the signal power versus sample number are provided for the six lower frequency bands in Figure 46 to Figure 51. Corresponding histograms and empirical cumulative density functions (CDFs) are found in Figure 52 and Figure 53. In these experiments, approximately 500 samples were collected for each frequency over the complete building walk-through, and the time between samples was approximately 6 seconds. The reference level for the six frequencies is much higher than that used in most subsequent experiments, which suggests a starting location quite close to the receiver site. As we will see, the standard deviation results are quite similar to results from the other buildings. Also, this particular building had been prepared for demolition, and thus did not contain material such as window glass. This removal of substantial portions of building material, as well as internal content, may have impacted the data. We also performed measurements before, during, and after the implosion of this structure and details of these implosion measurements are reported in [5].

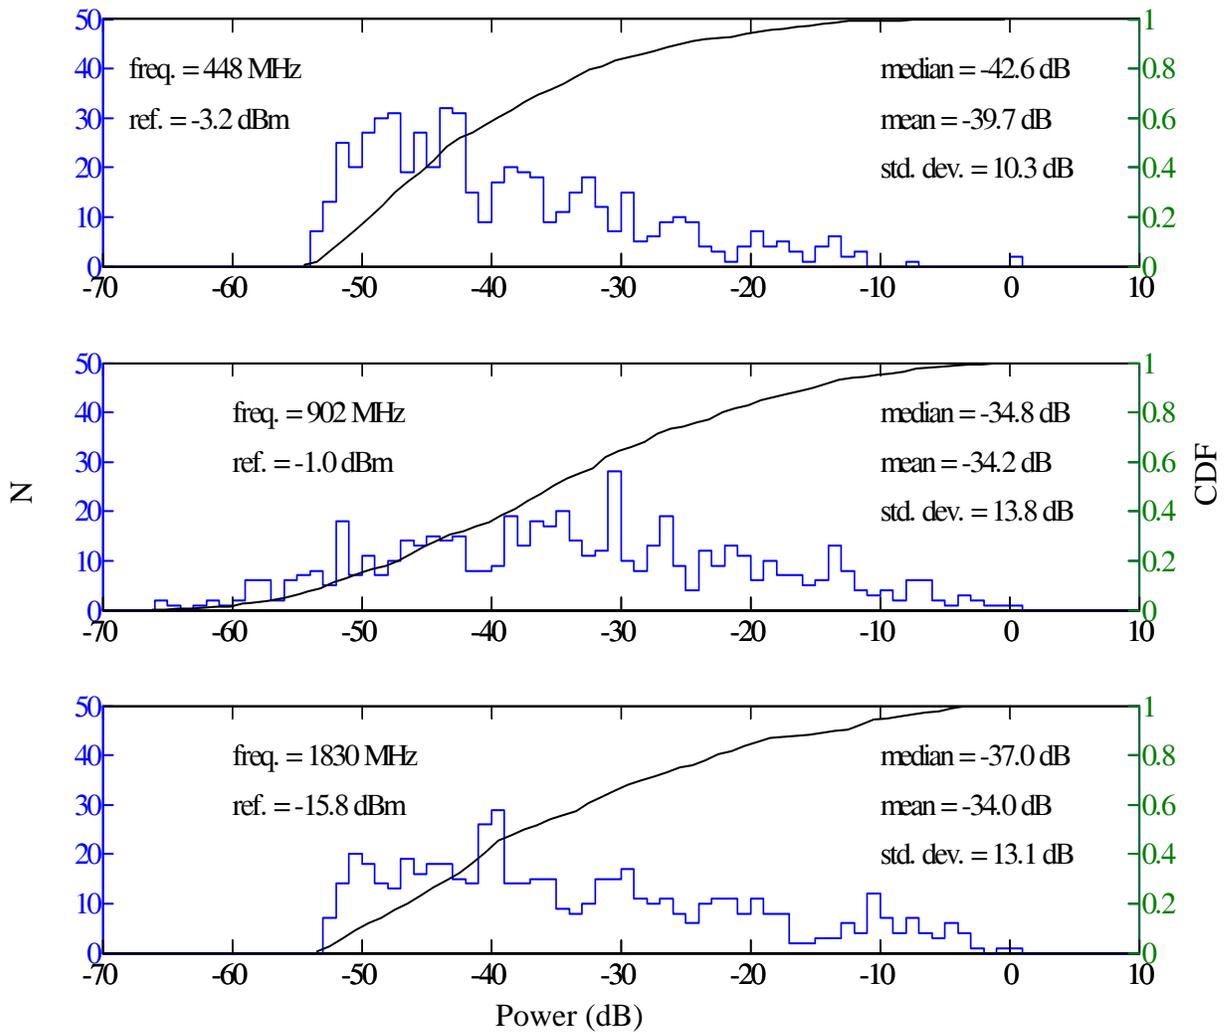
Figure 53. New Orleans apartment building statistics, histograms, and empirical CDF for walk-through data at 448.60, 902.60, and 1832.50 MHz.

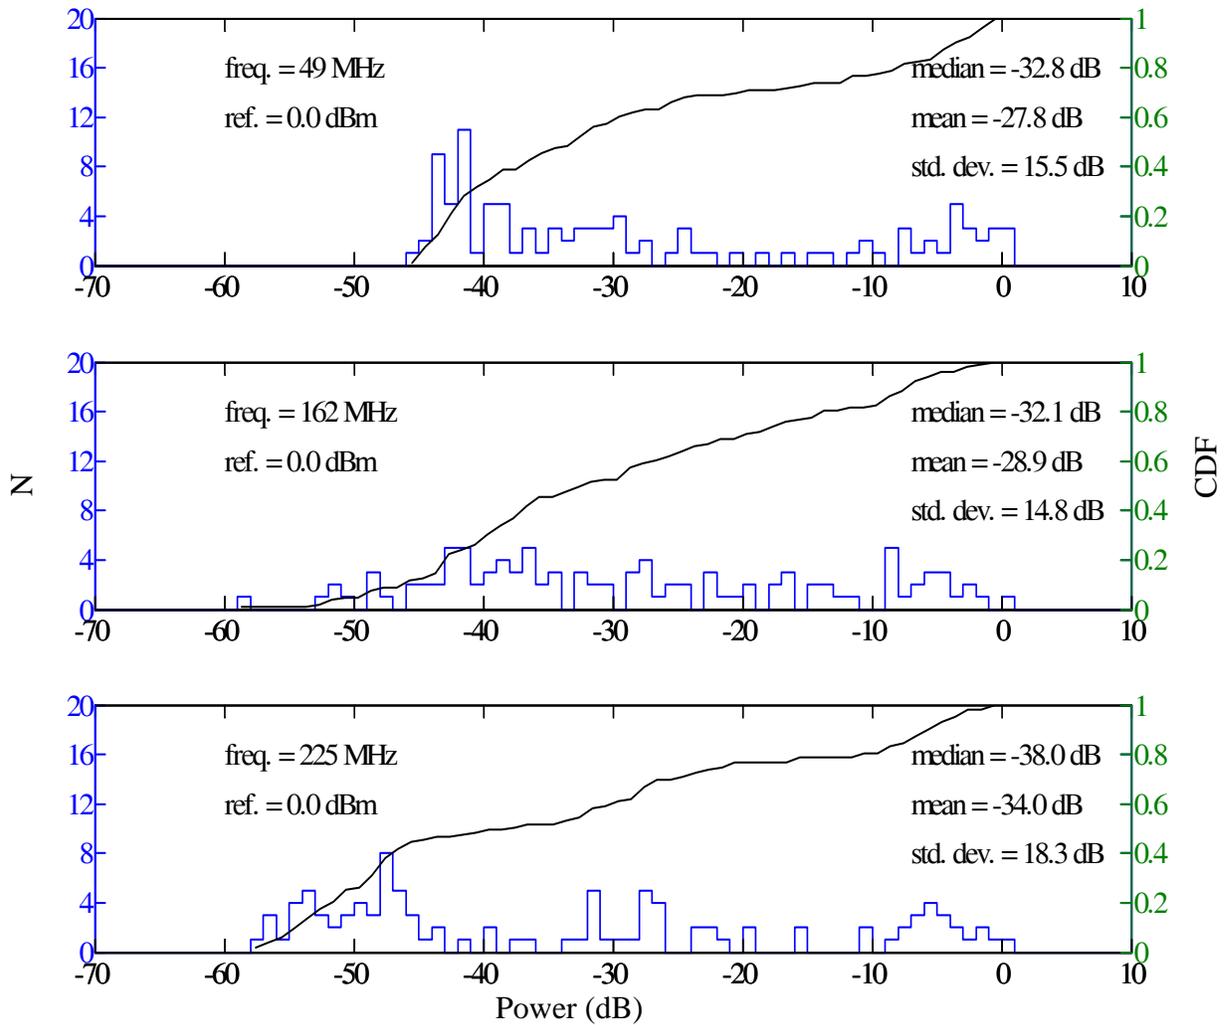
Figure 84. Philadelphia sports stadium statistics, histograms, and empirical CDF for outside walk data at 49.60, 162.09, and 225.30 MHz; horizontal polarization.

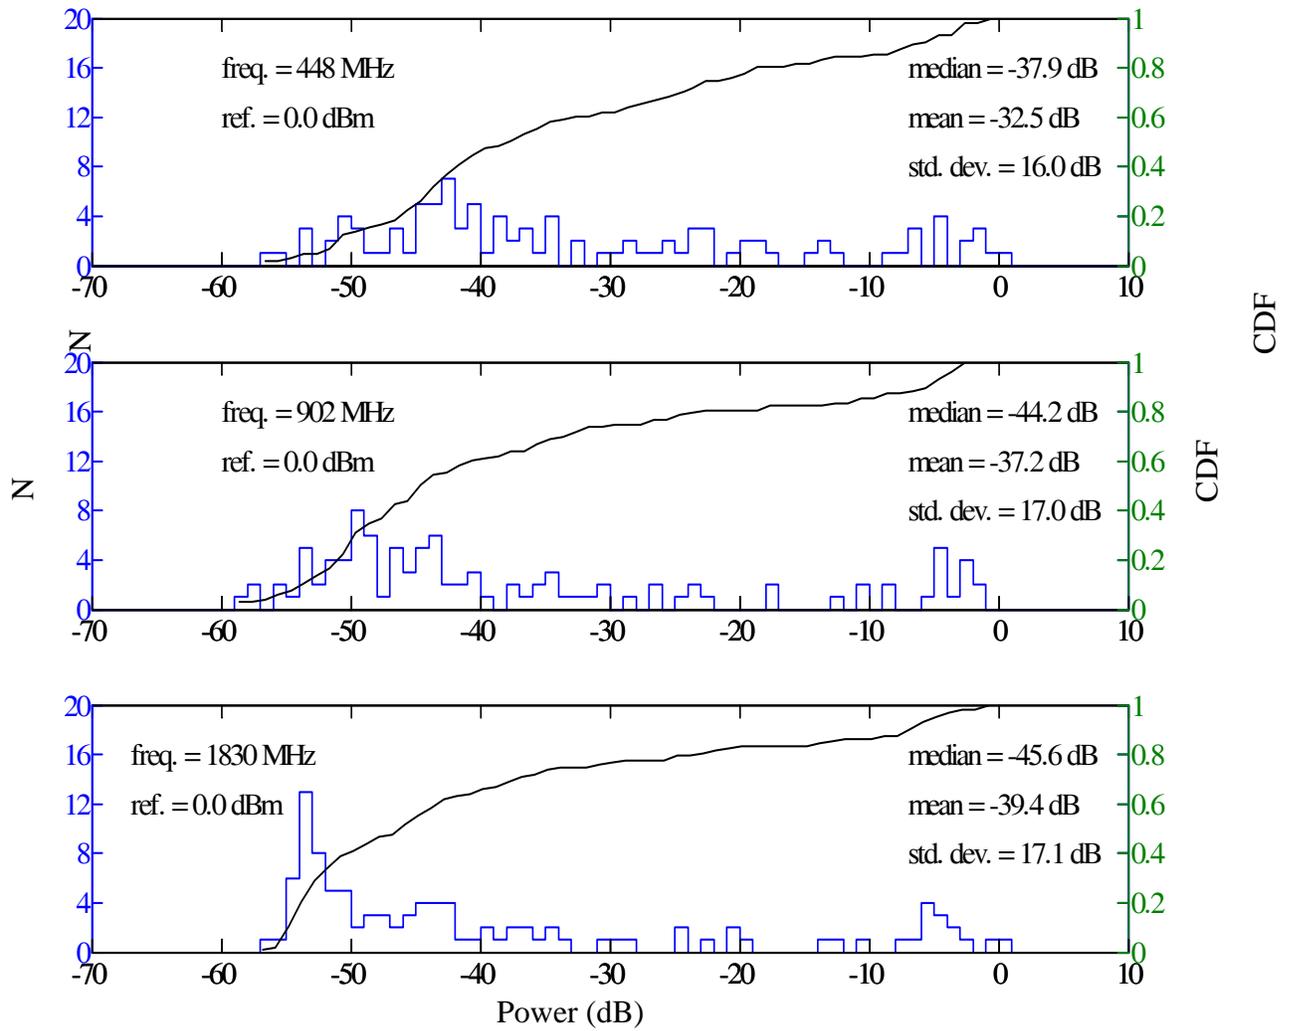
Figure 85. Philadelphia sports stadium statistics, histograms, and empirical CDF for outside walk data at 448.50, 902.45, and 1832.00 MHz; horizontal polarization

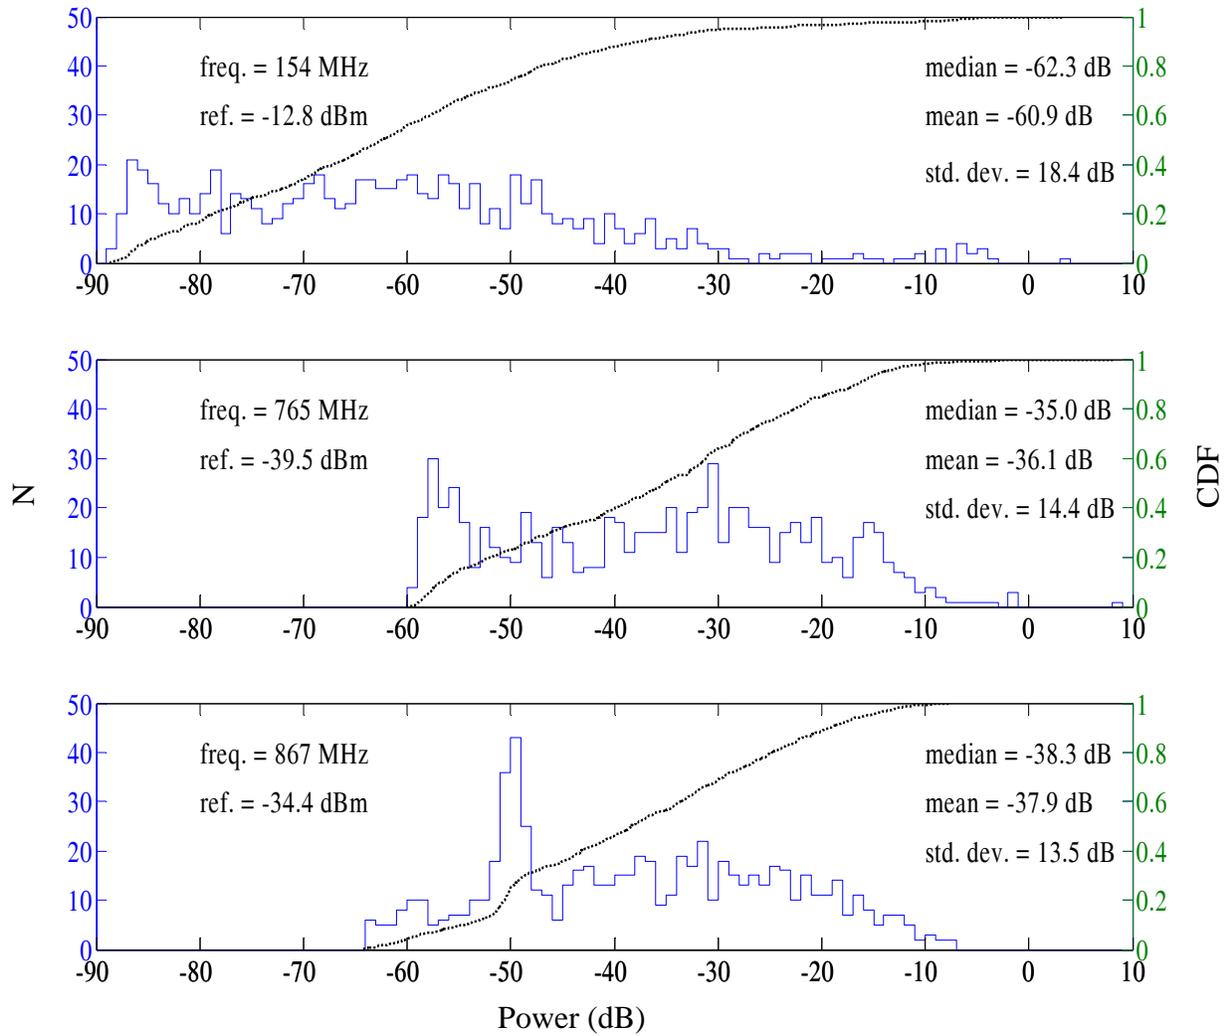
Figure 97. Phoenix office building statistics, histograms, and empirical CDF for walk-through data at 154, 765, and 867 MHz.

Three frequencies were measured at the Phoenix office building experiments described in Section 5.3. Walk-through plots are provided in Figure 94 through Figure 96, and the corresponding statistical plots are shown in Figure 97. As noted on the walk-through plots, a line-of-sight to the receiver location was possible only for the 154 MHz case. However, this did not appear to significantly alter the overall statistics in Figure 97, which depicts both a higher reference value and a larger standard deviation for the 154 MHz case, as compared to either the 765 or 867 MHz cases.

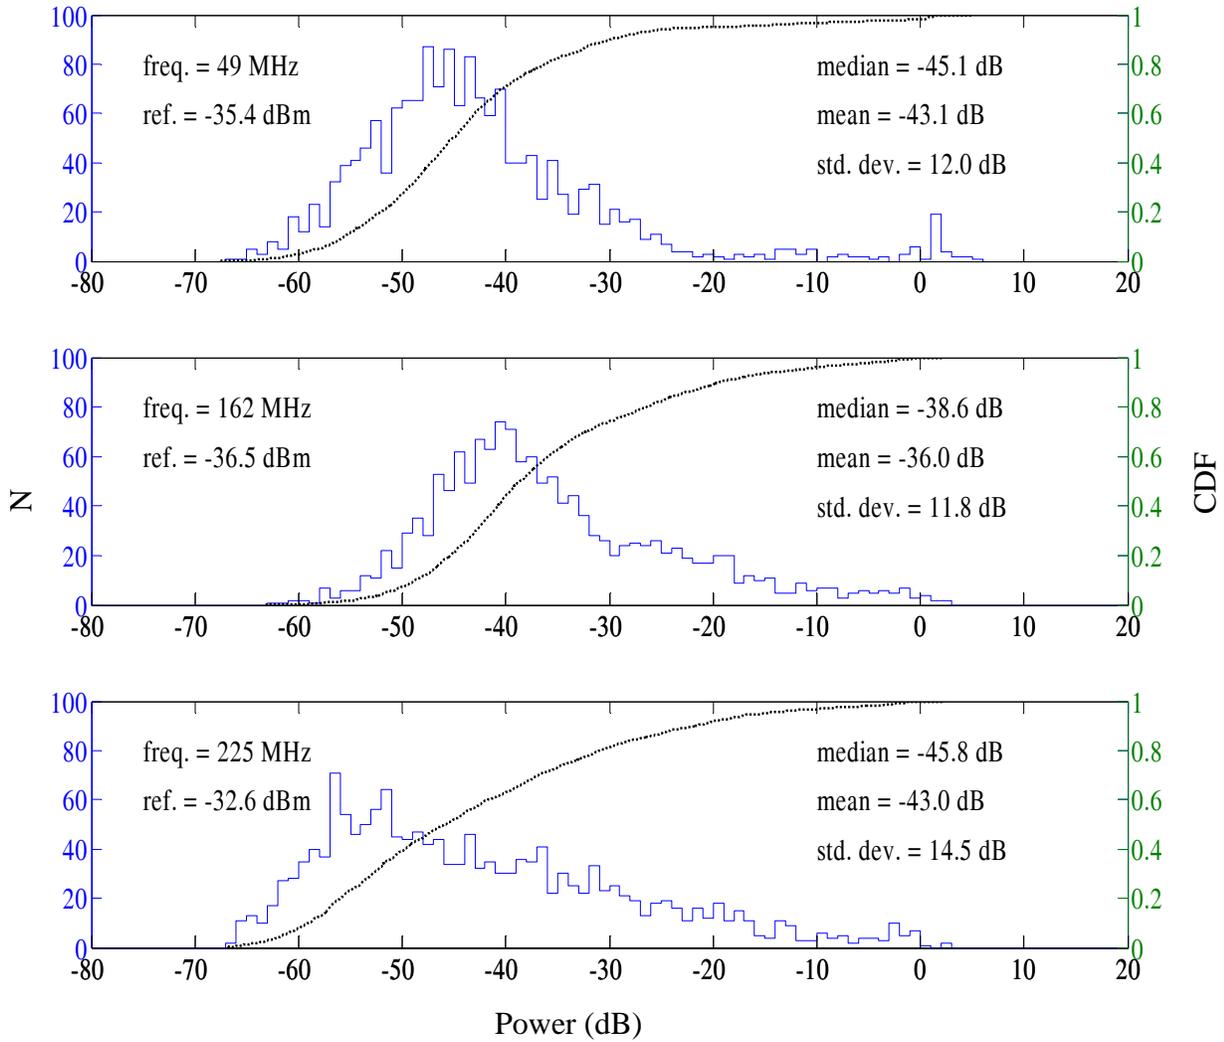
Figure 136. Boulder grocery store statistics, histograms, and empirical CDF for walk-through data; 49.60, 162.09, and 225.30 MHz.

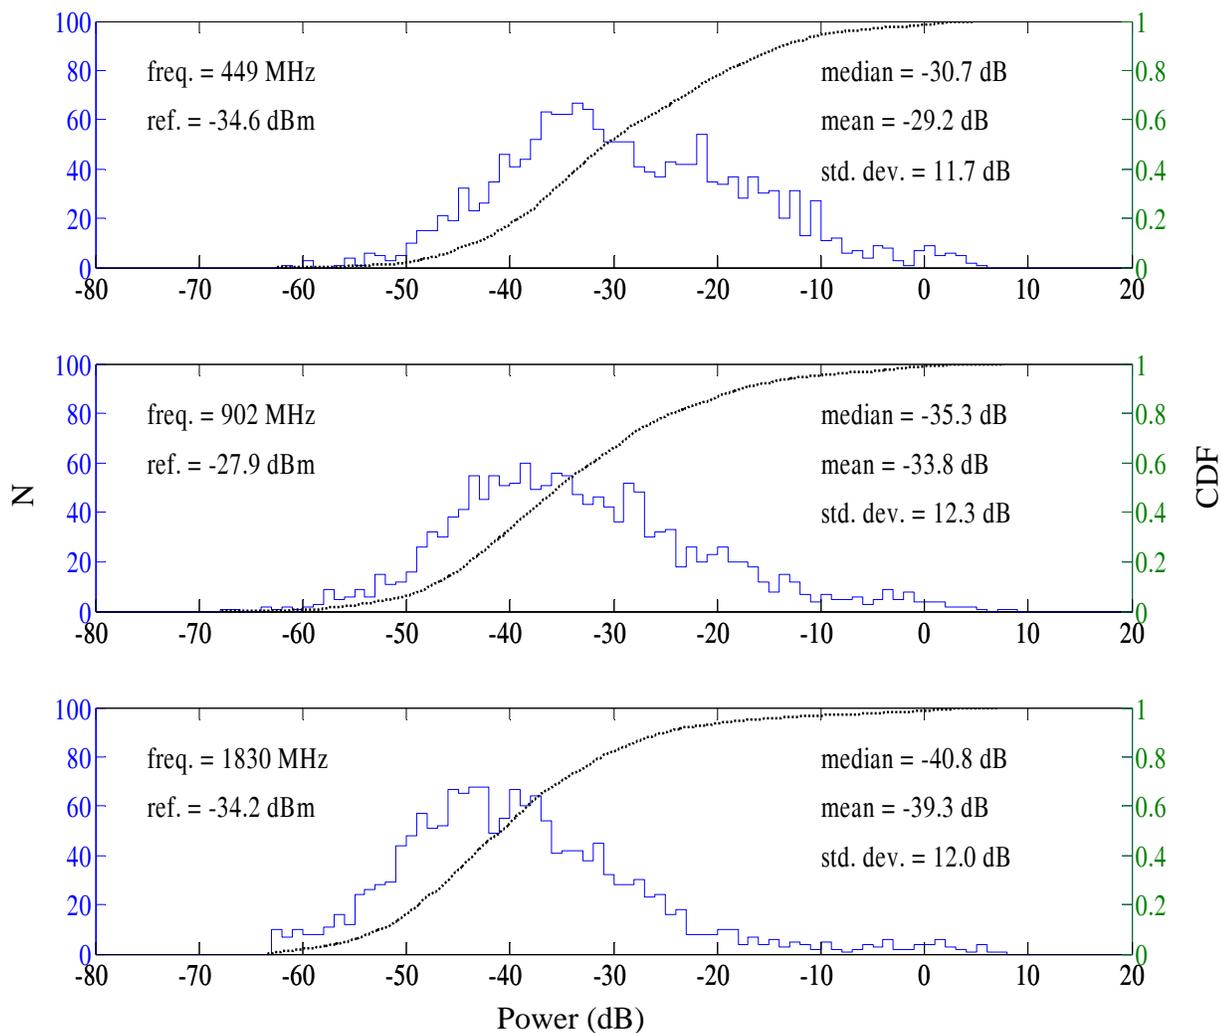
Figure 137. Boulder grocery store statistics, histograms, and empirical CDF for walk-through data. 1; 448.50, 902.75, and 1830.00 MHz.

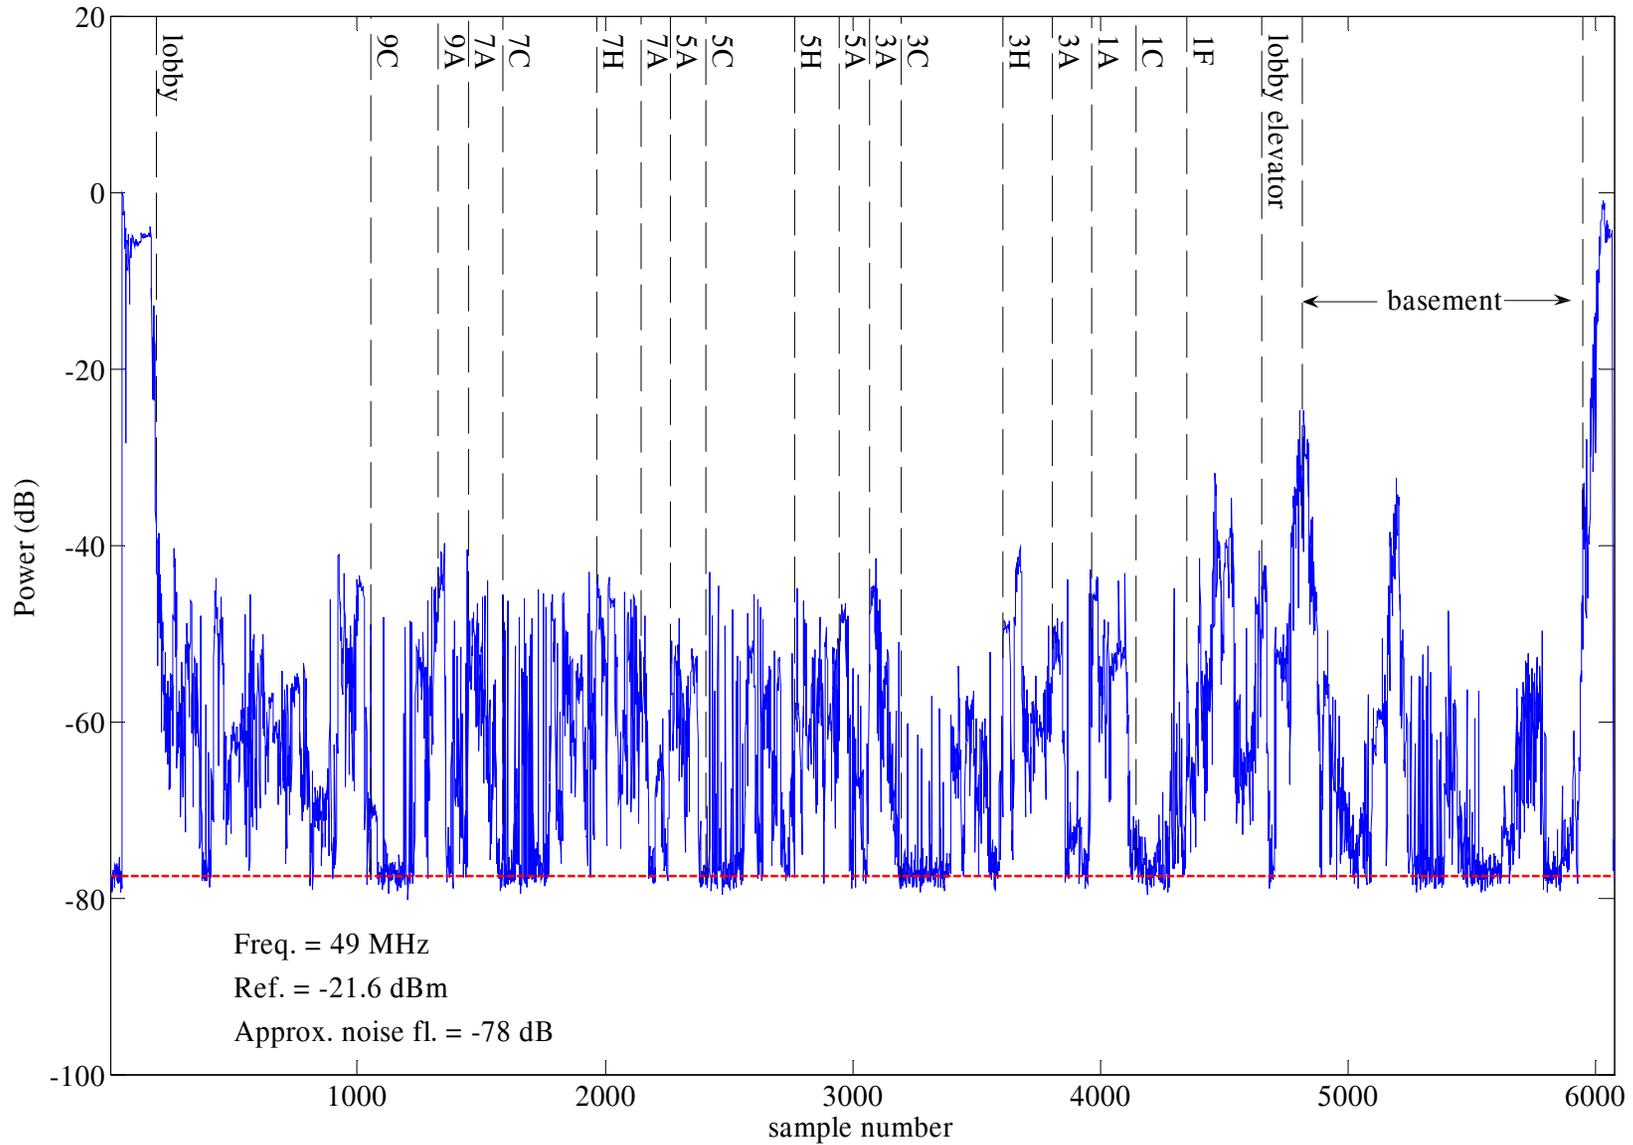
Figure 162. Silver Spring office building walk-through at 49.60 MHz.

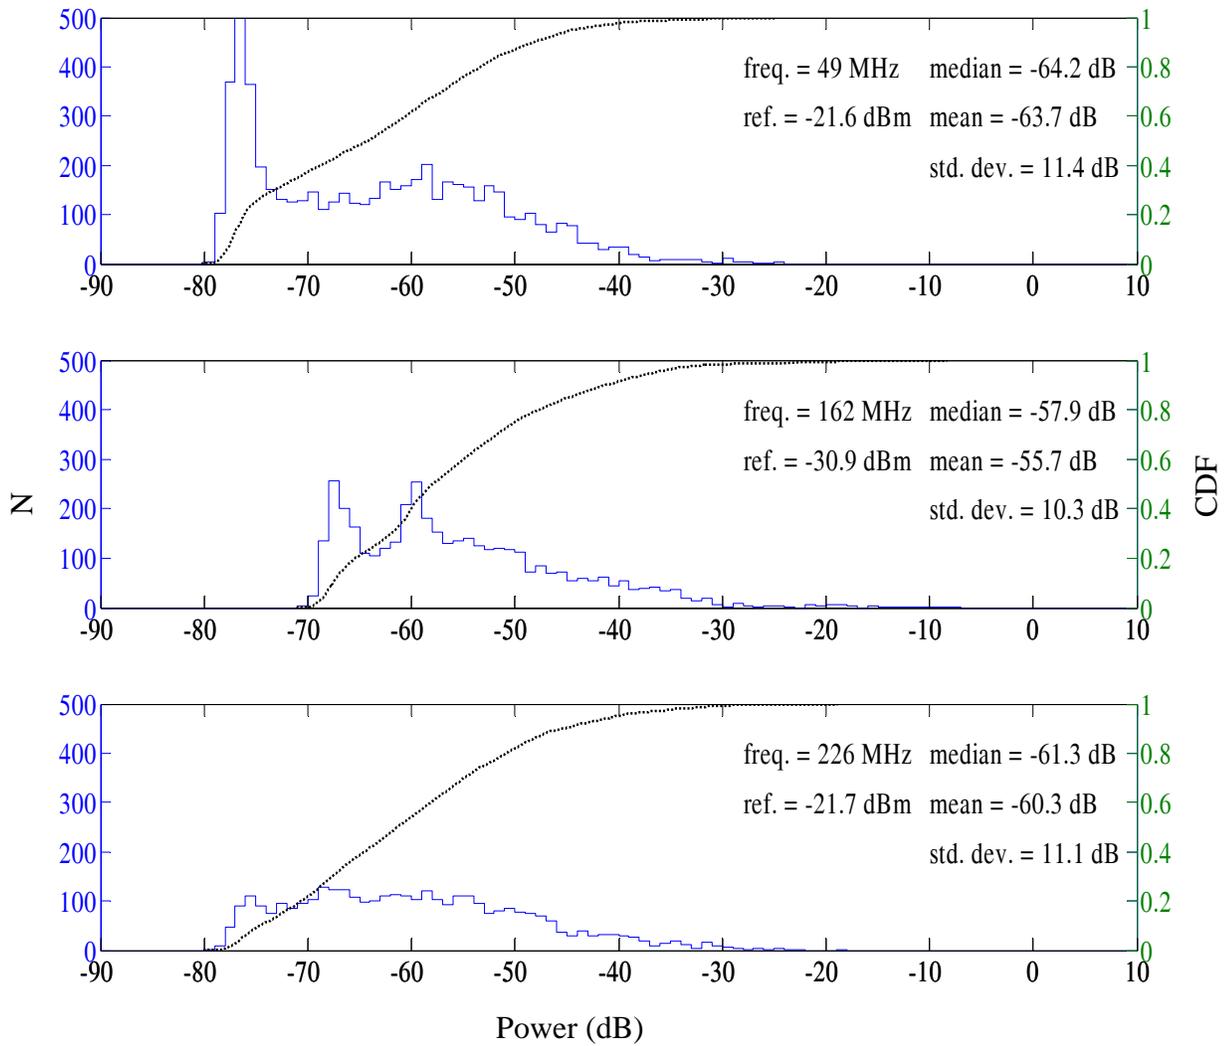
Figure 168. Silver Spring office building statistics, histograms, and empirical CDF for walk-through data; 49.60, 162.09, and 226.40 MHz.
