Preprint: NIST Technical Note 1545

Attenuation of Radio Wave Signals Coupled Into Twelve Large Building Structures

NIST Technical Note 1545

May 2008

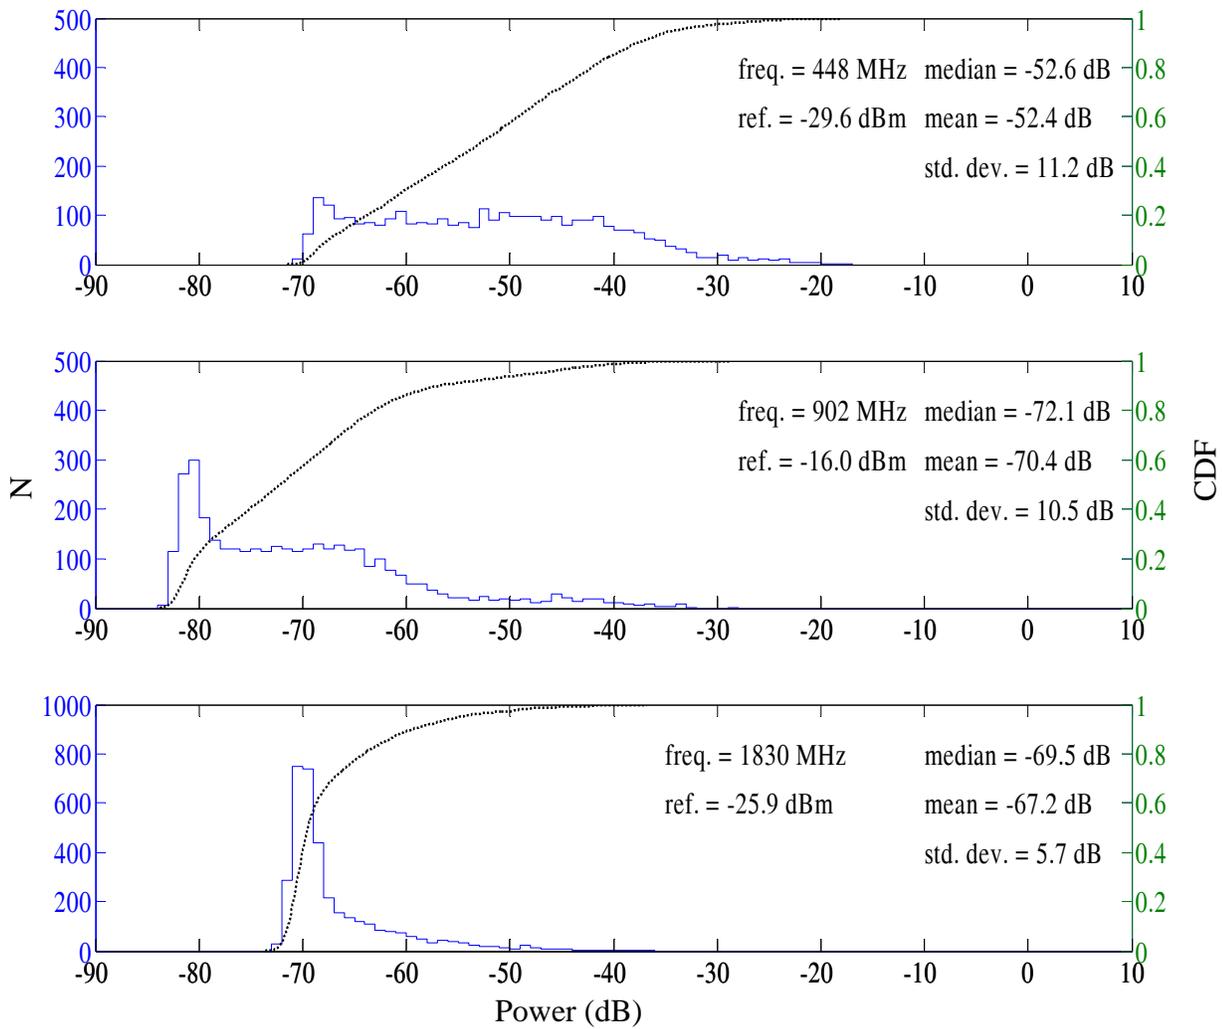
Figure 169. Silver Spring office building statistics, histograms, and empirical CDF for walk-through data; 448.30, 902.45, and 1830.00 MHz.

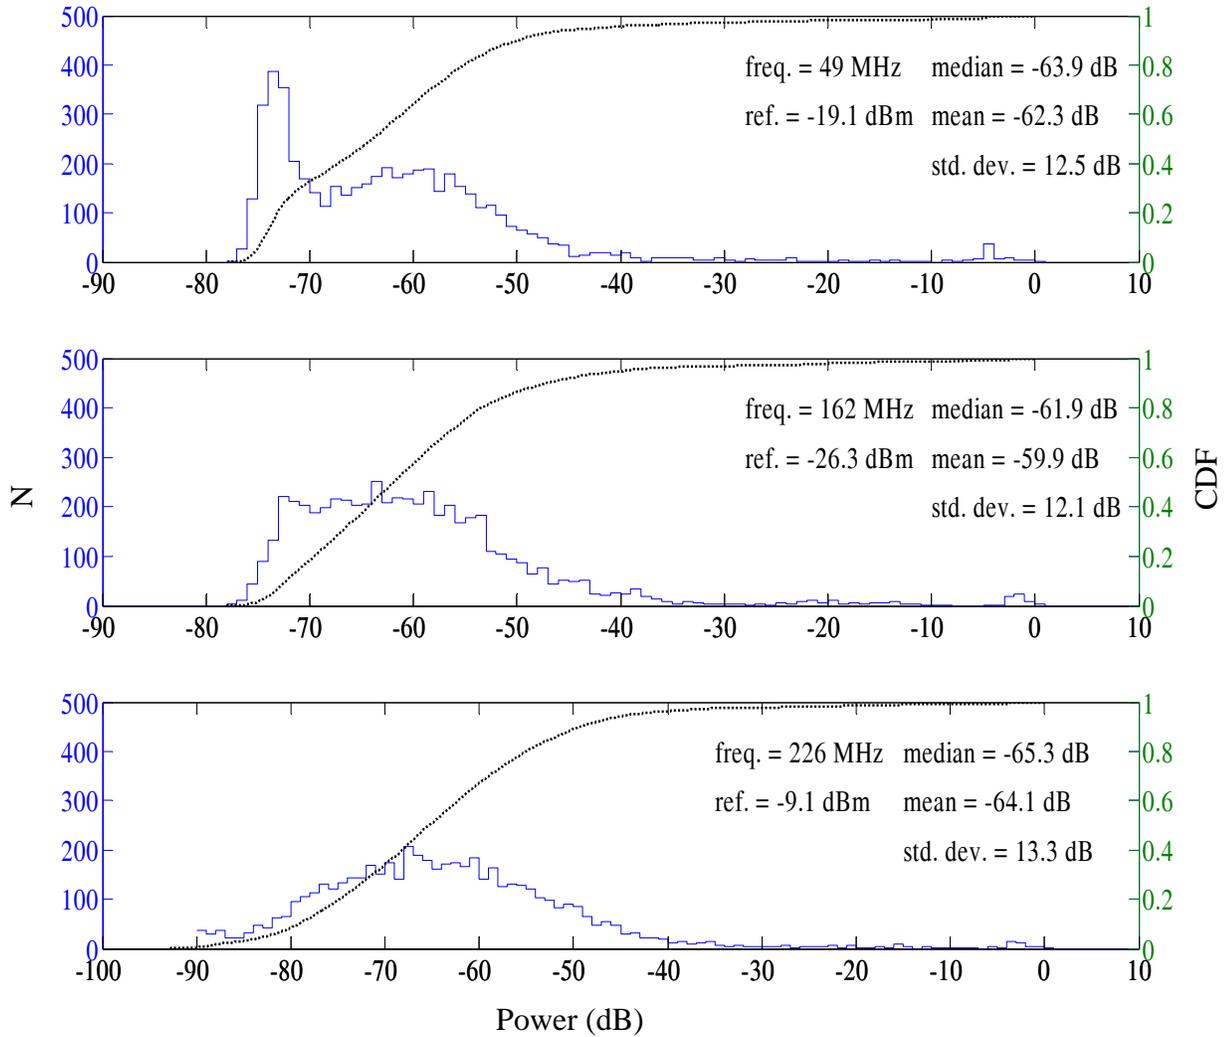
Figure 176. DC Convention Center statistics, histograms, and empirical CDF for walk-through data with the receiver at site 1; 49.60, 162.09, and 226.40 MHz.

Three receiver sites collected data at the Washington DC Convention Center. The corresponding walk-through data results for receiver sites labeled 1, 2, and 3 are provided in Figure 170 through Figure 175, Figure 178 through Figure 183, and Figure 186 through Figure 191, respectively. The statistics plots for receiver sites 1, 2, and 3 are found in Figure 176 and Figure 177, Figure 184 and Figure 185, and Figure 192 and Figure 193, respectively.

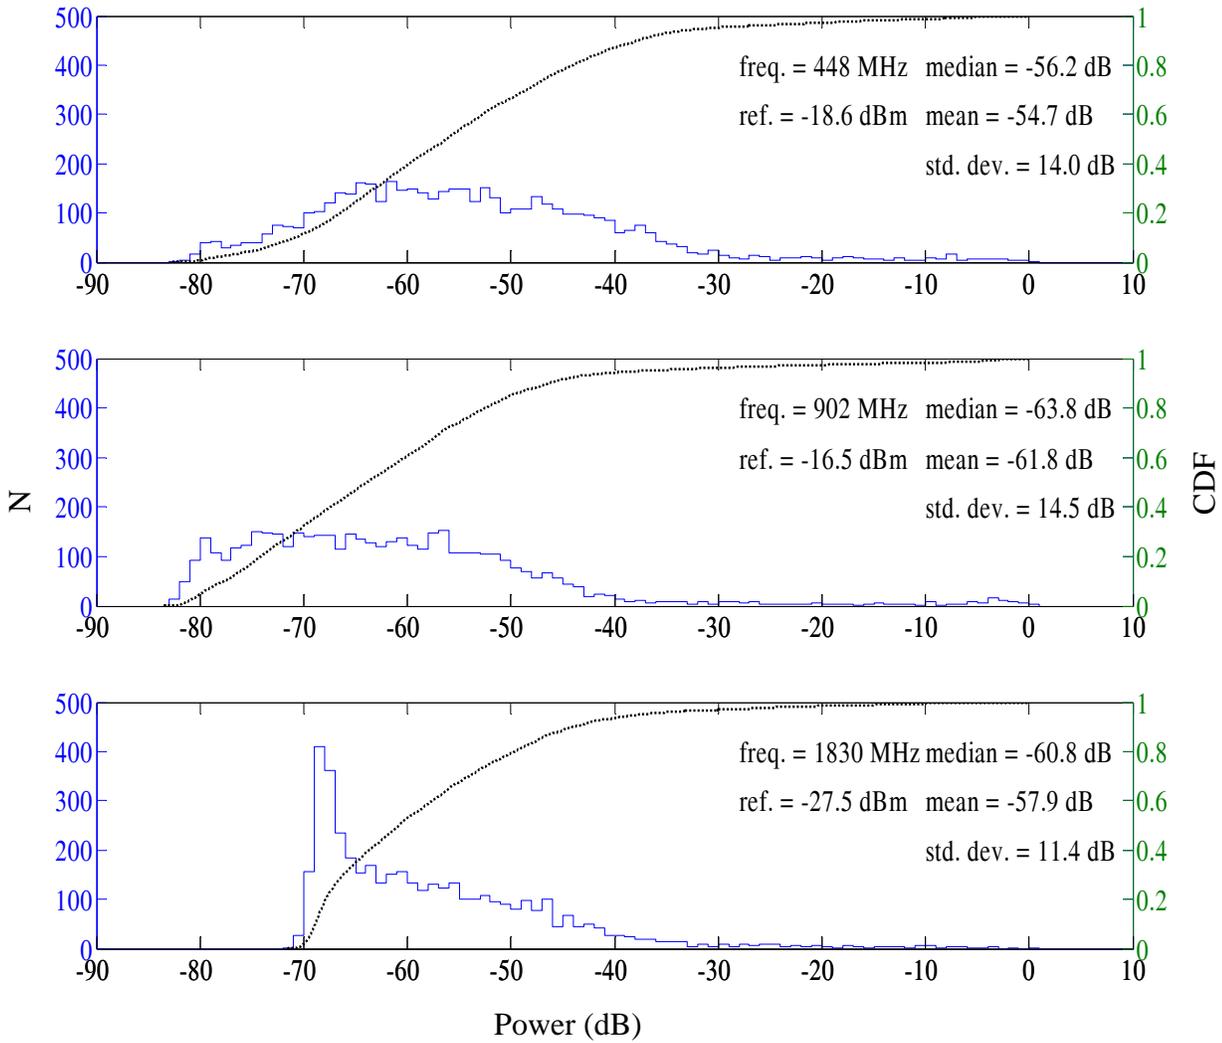
Figure 177. DC Convention Center statistics, histograms, and empirical CDF for walk-through data with the receiver at site 1; 448.30, 902.45, and 1830.00 MHz.

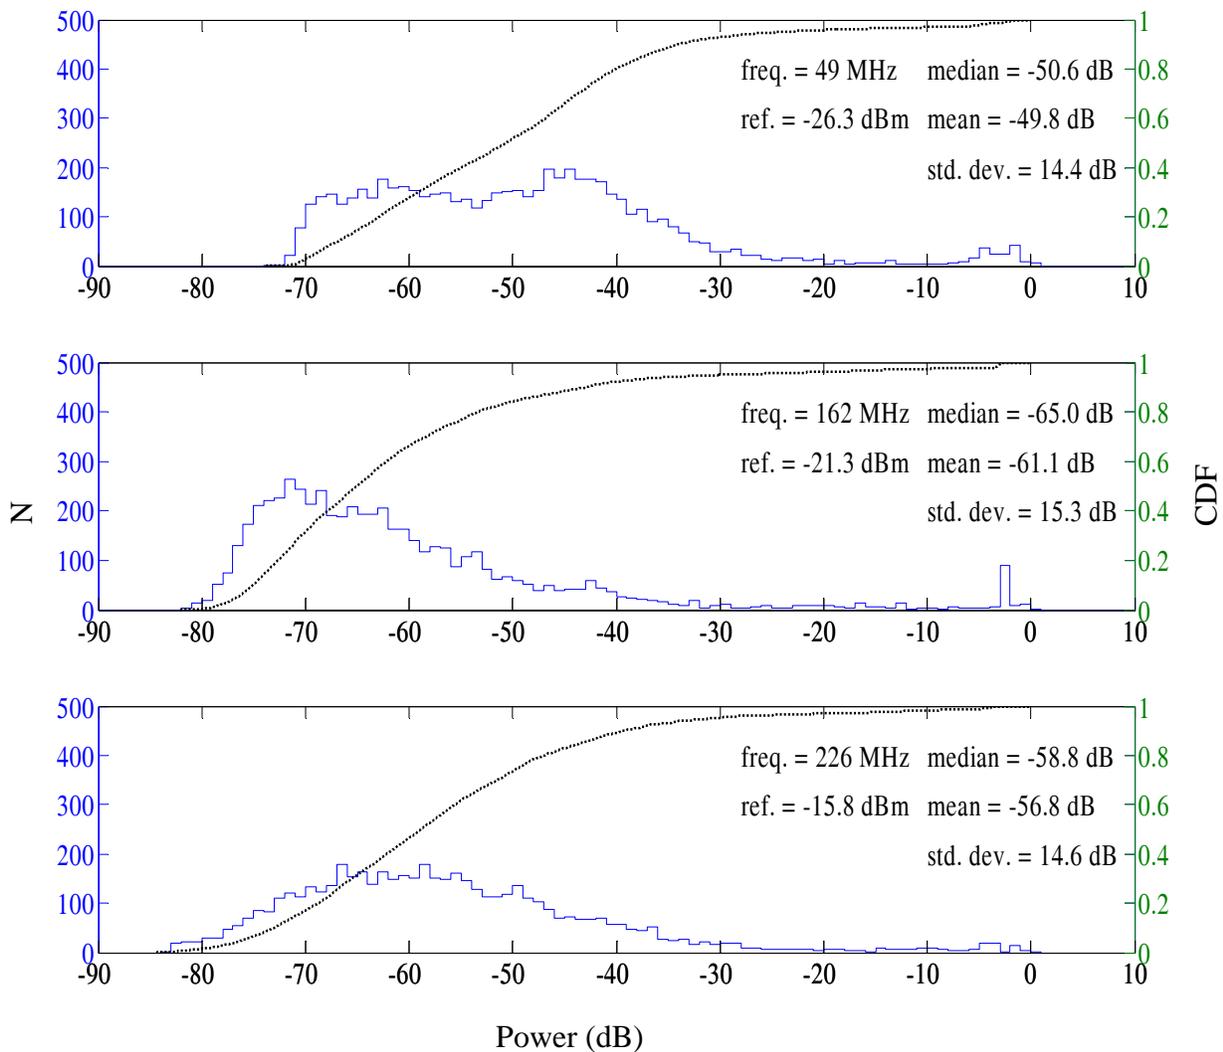
Figure 184. DC Convention Center statistics, histograms, and empirical CDF for walk-through data with the receiver at site 2; 49.60, 162.09, and 226.40 MHz.

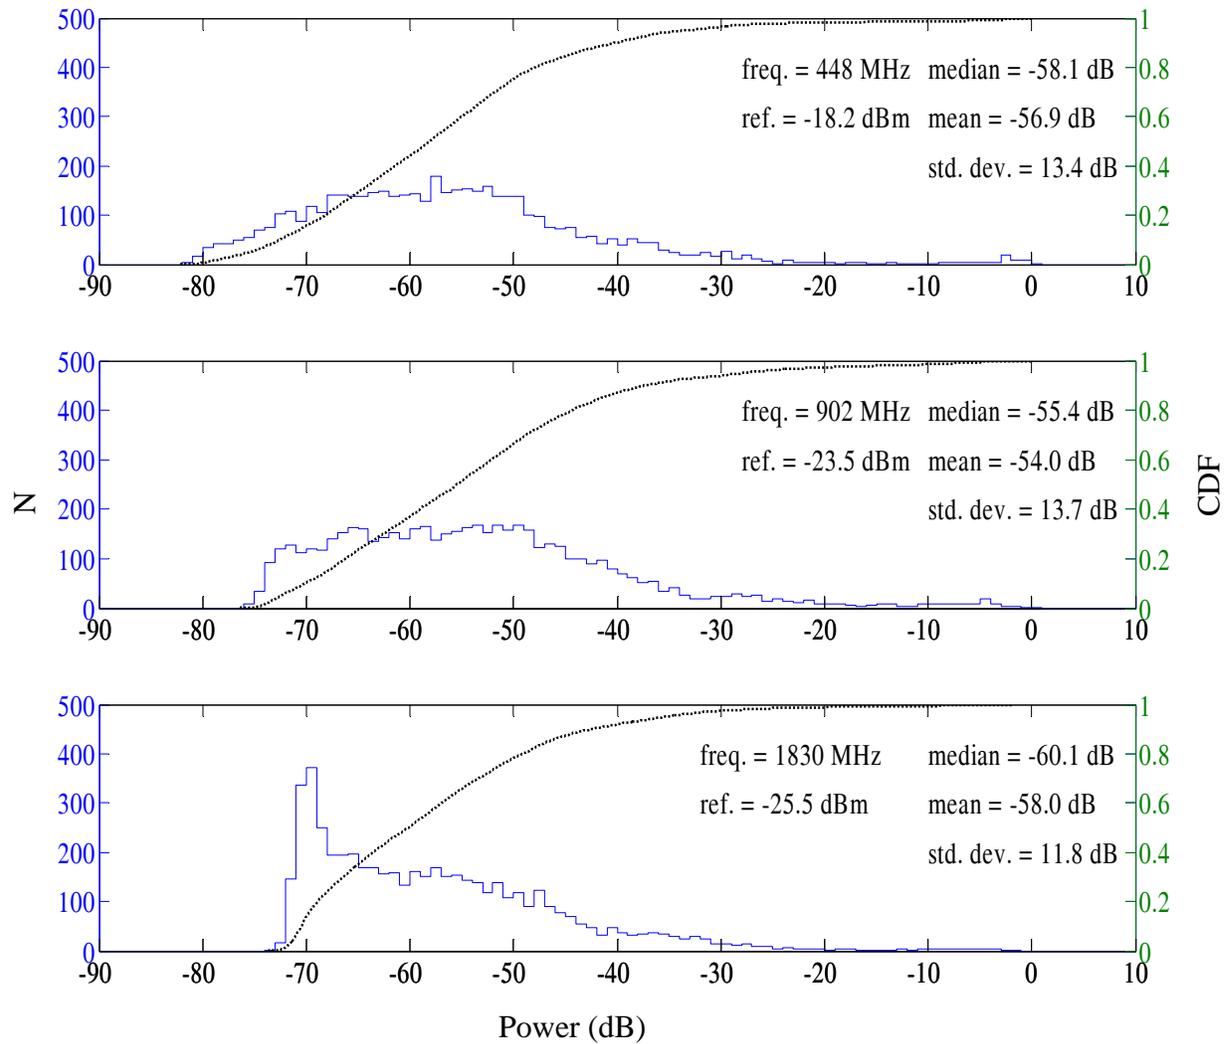
Figure 185. DC Convention Center statistics, histograms, and empirical CDF for walk-through data with the receiver at site 2; 448.30, 902.45, and 1830.00 MHz.

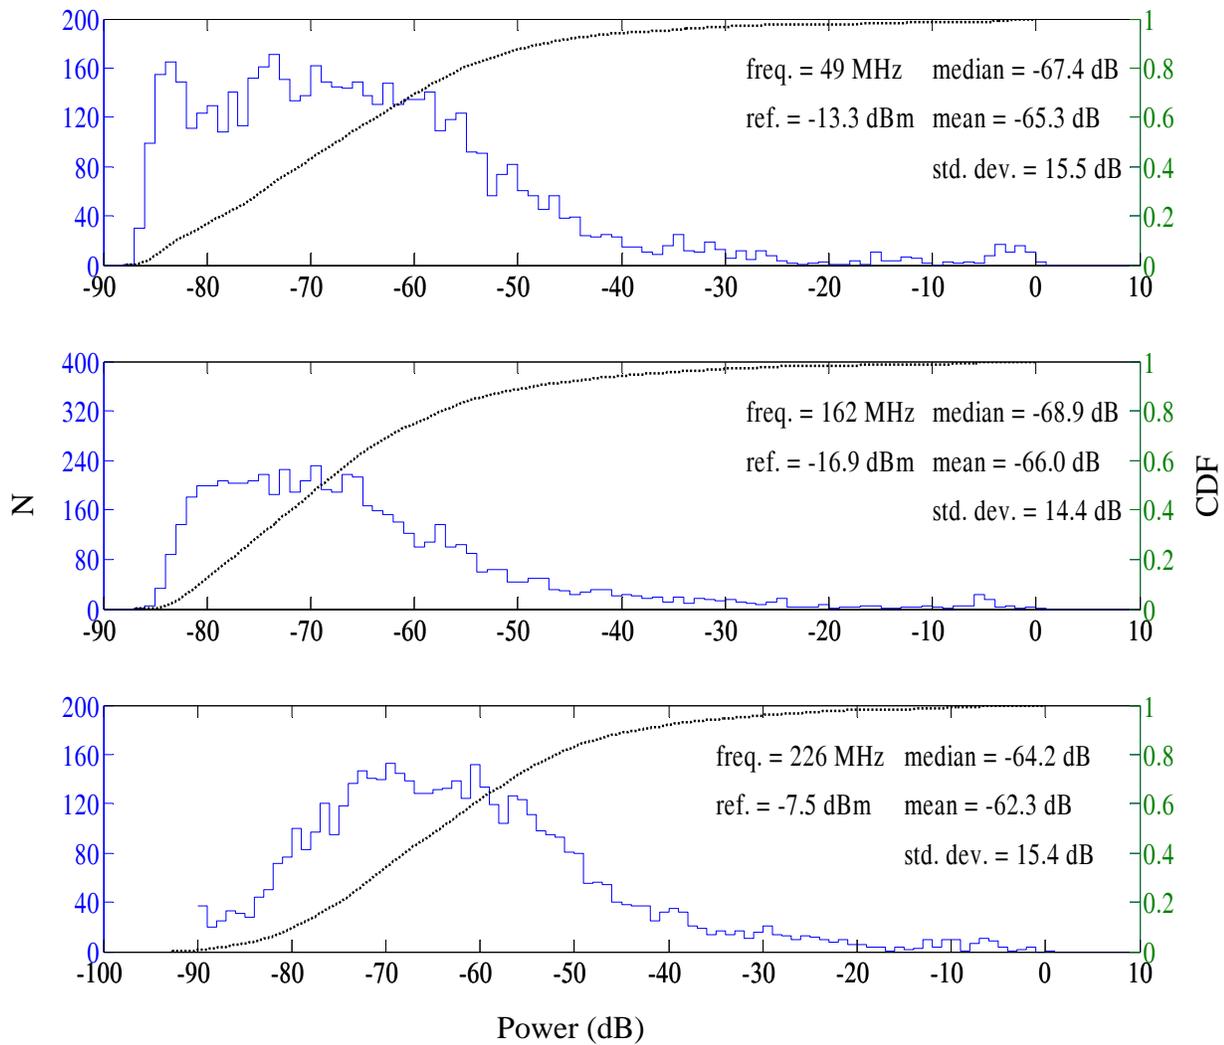
Figure 192. DC Convention Center statistics, histograms, and empirical CDF for walk-through data with the receiver at site 3; 49.60, 162.09, and 226.40 MHz.

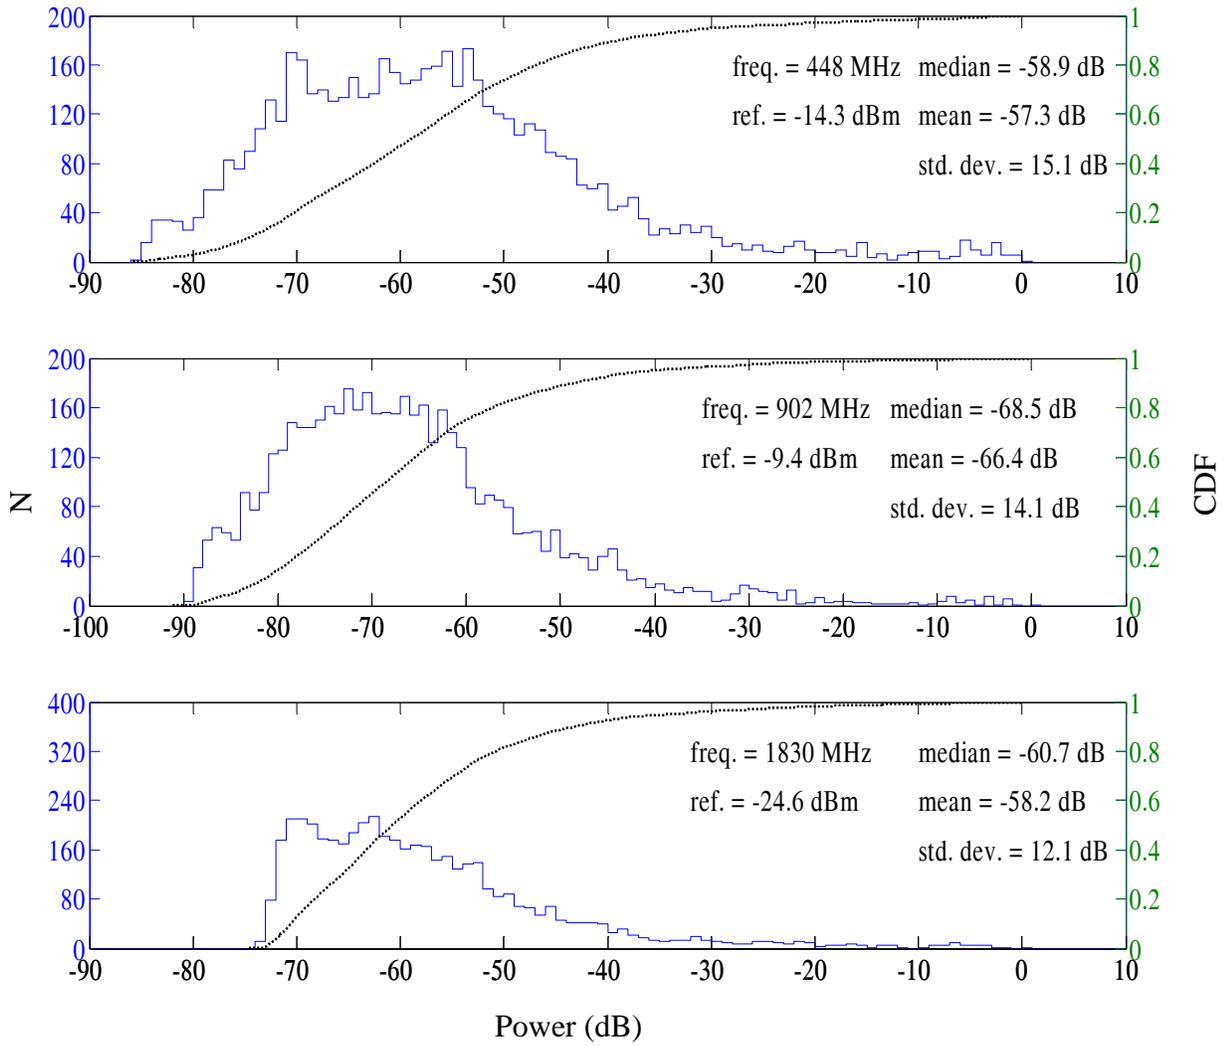
Figure 193. DC Convention Center statistics, histograms, and empirical CDF for walk-through data with the receiver at site 3; 448.30, 902.45, and 1830.00 MHz.
